# **CHARACTER-DEFINING FEATURE STUDY**

## **GOLDEN GATE VILLAGE, MARIN CITY, CA**

**September 2019**

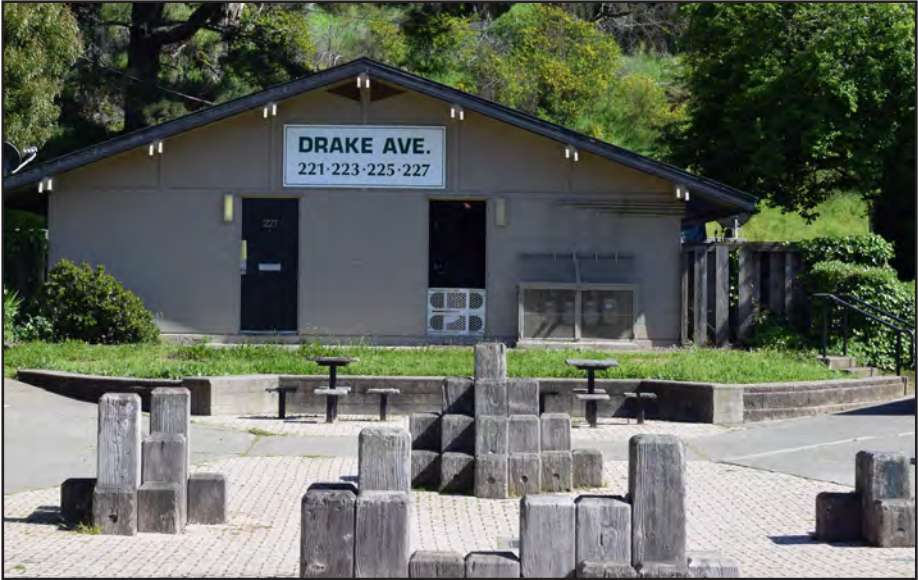
| Character Defining Features | Landscape Characteristic | Feature | Photo | Description | Date Built | Integrity |
|---|---|---|---|---|---|---|
| | Cluster Arrangement | Shared courtyards | | The location and spatial organization of the courtyards is extant, although the furnishings within the courtyards were redesigned in 1984. | 1959-1961 | Medium |

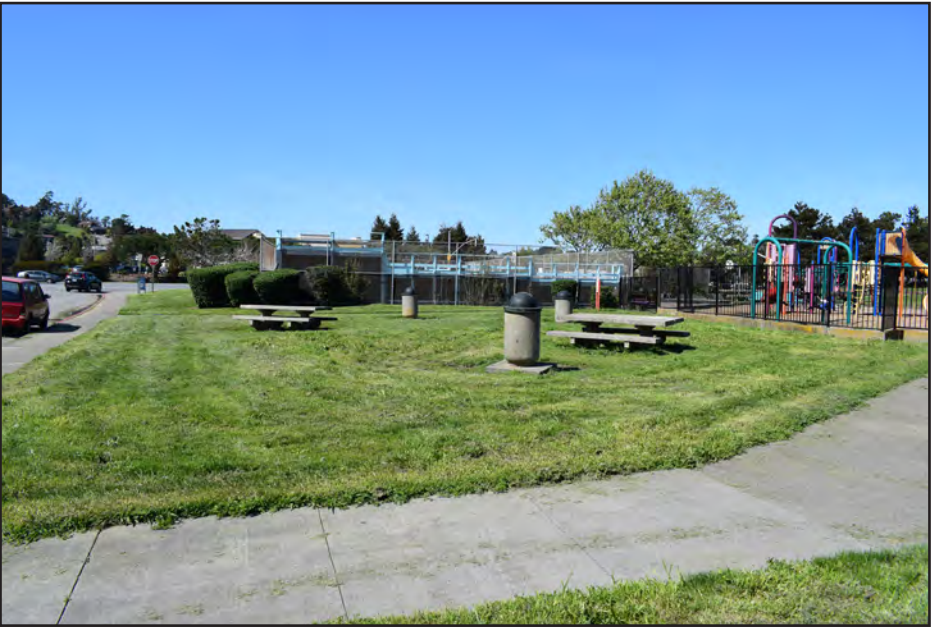
| Character Defining Features | Landscape Characteristic | Feature | Photo | Description | Date Built | Integrity |
|---|---|---|---|---|---|---|
| | Land Use | Recreation use | | <p>The recreation cluster was designed with a baseball field but has been redesigned for different recreational uses over time.</p> | 1959-1961 | Low |

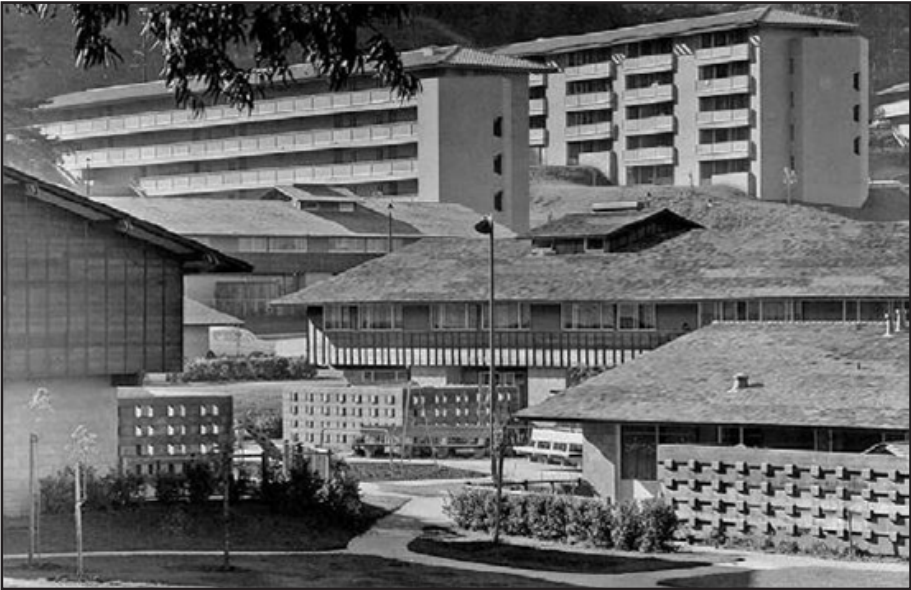
| Character Defining Features | Landscape Characteristic | Feature | Photo | Description | Date Built | Integrity |
|---|---|---|---|---|---|---|
| | Vegetation | Hedges in low-rise cluster | <p>Source: Ruark, 2017.</p> | Hedges surrounding low-rise buildings (where remaining). | 1959-1961 | Low |

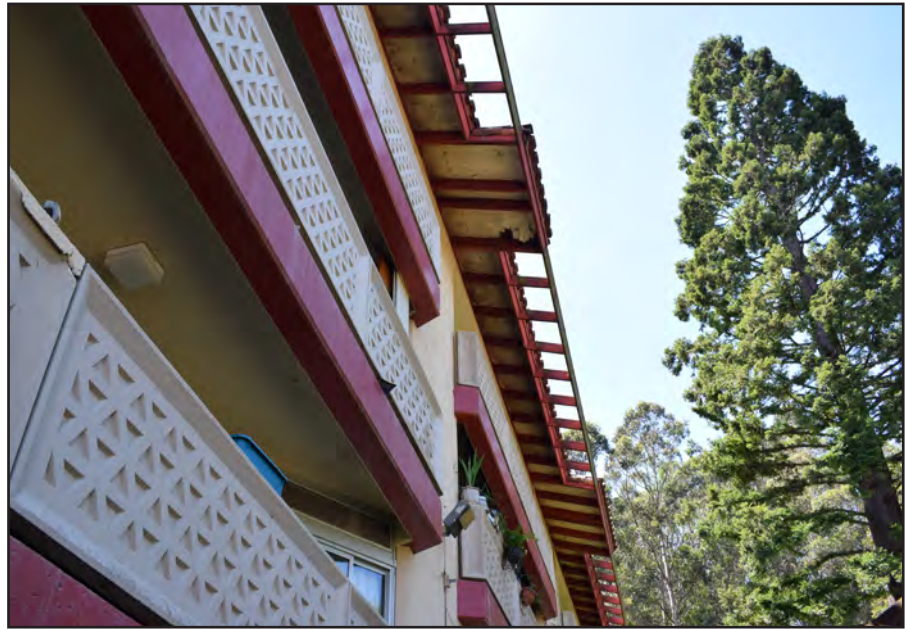
| Character Defining Features | Landscape Characteristic | Feature | Photo | Description | Date Built | Integrity |
|---|---|---|---|---|---|---|
| | Buildings and Structures | Precast concrete guardrails (High-rise buildings) | | Precast concrete guardrails along open walkways and at private balconies. | 1959-1961 | Low |

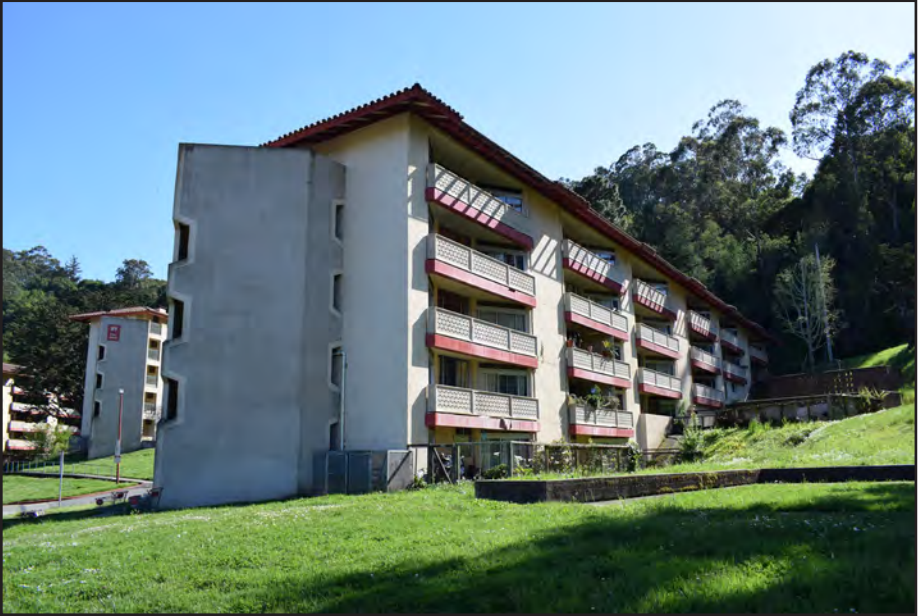
| Character Defining Features | Landscape Characteristic | Feature | Photo | Description | Date Built | Integrity |
|---|---|---|---|---|---|---|
| | Buildings and Structures | High-rise building staircases (High-rise buildings) | | Concrete stairways at both ends of the high-rise buildings. | 1959-1961 | Low |

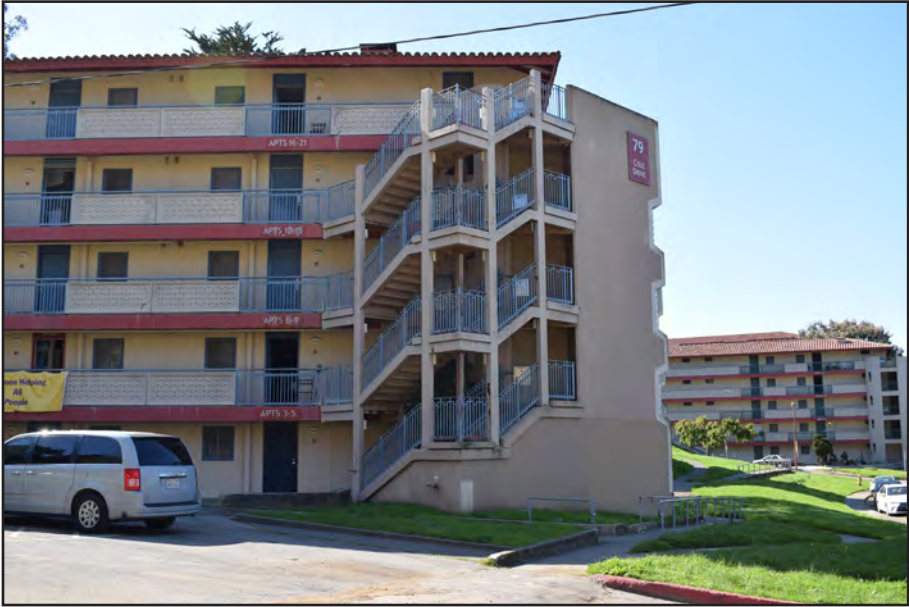
| Character Defining Features | Landscape Characteristic | Feature | Photo | Description | Date Built | Integrity |
|---|---|---|---|---|---|---|
| | Buildings and Structures | Location of doors and windows (High-rise buildings) | | The locations of the doors and windows. The fenestration has been replaced in large part over time, and some doors have been widened to accommodate ADA improvements. | 1959-1961 | Medium |

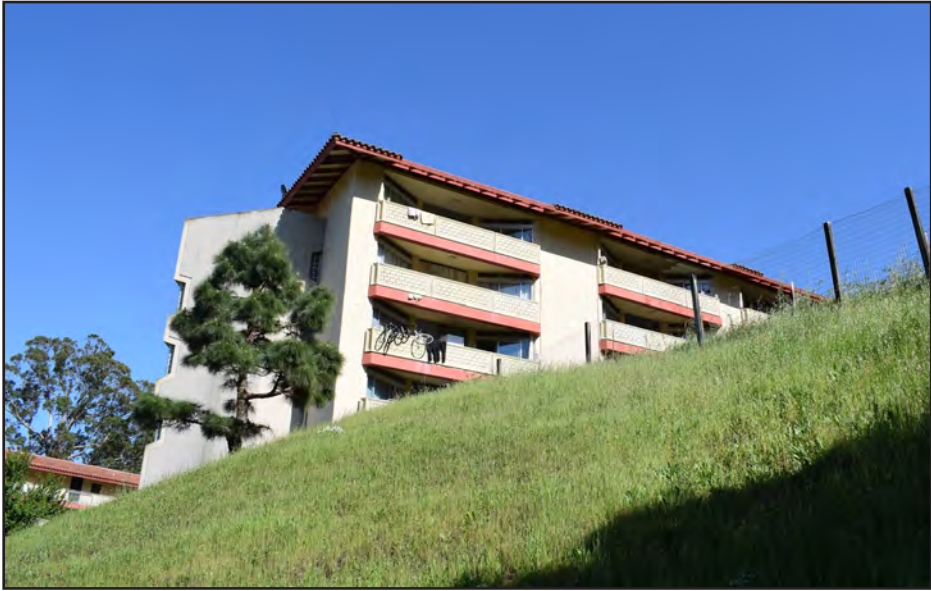
| Character Defining Features | Landscape Characteristic | Feature | Photo | Description | Date Built | Integrity |
|---|---|---|---|---|---|---|
| | Buildings and Structures | Exposed roof rafters (High-rise buildings) | | Exposed redwood roof rafters (sometimes referred to as “trellises”) over the balconies at the rear façades of high-rise buildings. Portions have been replaced in-kind. | 1959-1961 | High |

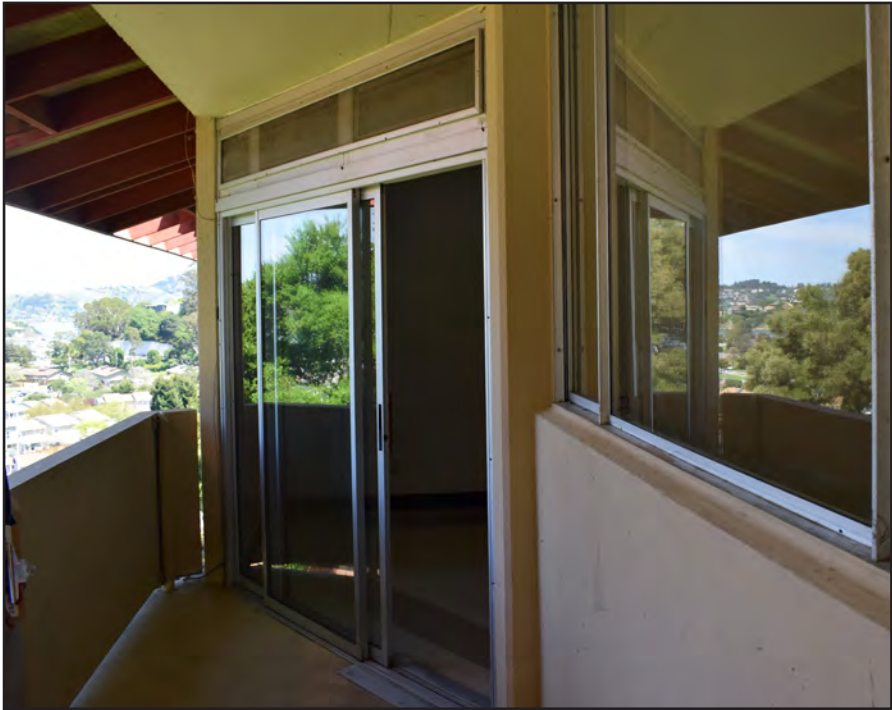
| Character Defining Features | Landscape Characteristic | Feature | Photo | Description | Date Built | Integrity |
|---|---|---|---|---|---|---|
| | Buildings and Structures | Sliding doors for balcony access (High-rise buildings) | | Two sets of sliding doors, separated by a window, that provide access to the private balconies in the high-rise units. The sliding doors are replacements. | 1959-1961 | Medium |

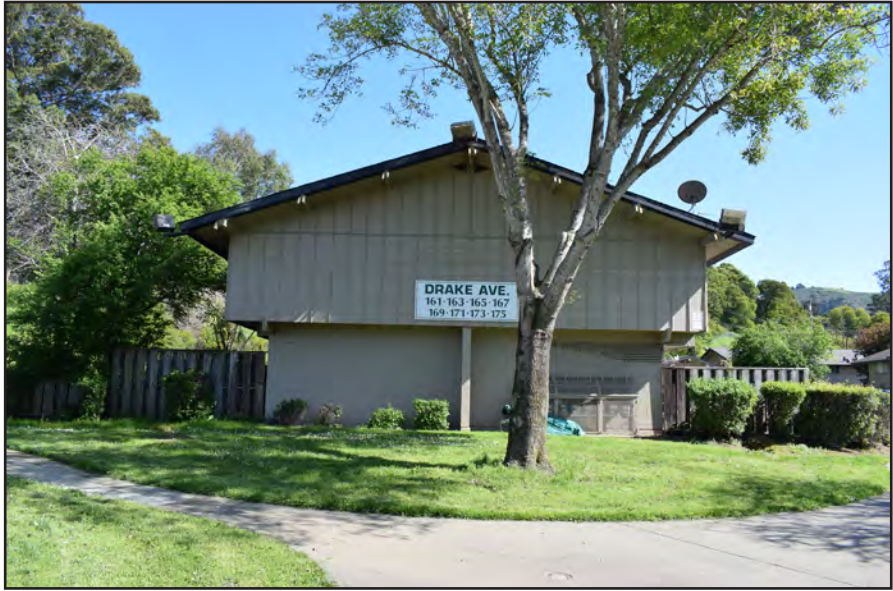
| Character Defining Features | Landscape Characteristic | Feature | Photo | Description | Date Built | Integrity |
|---|---|---|---|---|---|---|
| | Buildings and Structures | Gabled roofs with exposed rafters (Low-rise buildings) | | End gabled roof form with exposed rafters, the original wood shingles have been replaced with composite shingles. | 1959-1961 | Medium |

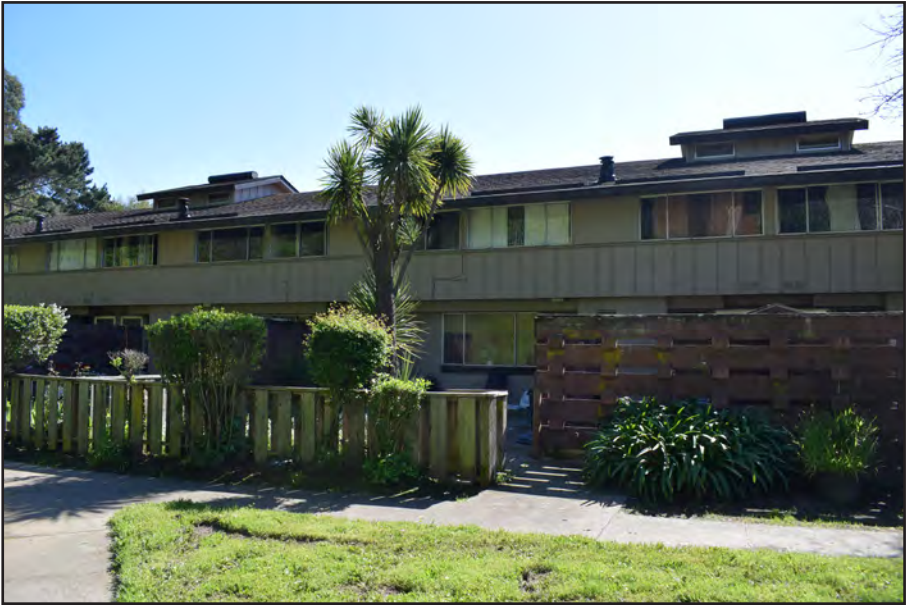
| Character Defining Features | Landscape Characteristic | Feature | Photo | Description | Date Built | Integrity |
|---|---|---|---|---|---|---|
| | Buildings and Structures | Ridge vents (Low-rise buildings) | | Two clerestory ridge vents at each Type B building. The shingles on the clerestories have been replaced. | 1959-1961 | Medium |

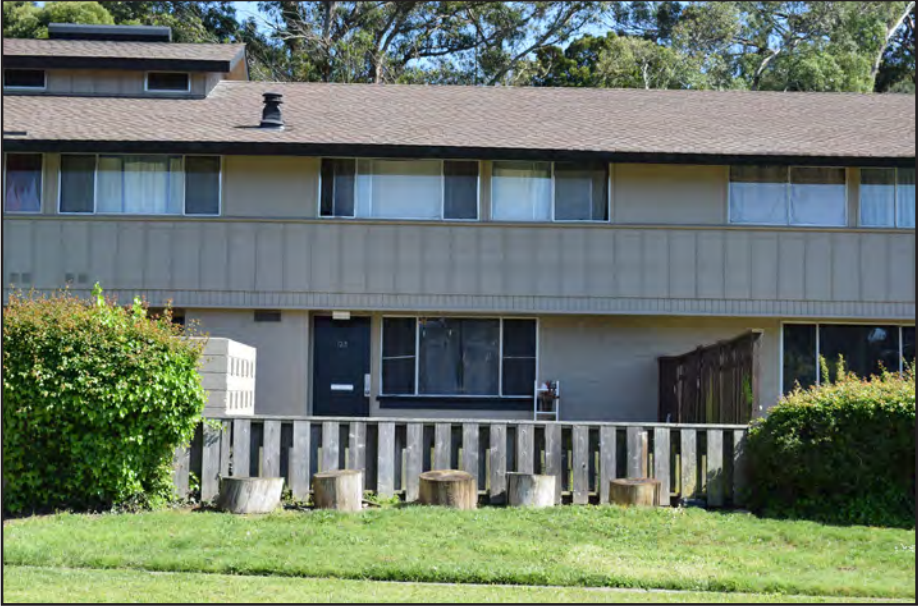
| Character Defining Features | Landscape Characteristic | Feature | Photo | Description | Date Built | Integrity |
|---|---|---|---|---|---|---|
| | Buildings and Structures | Concrete and wood construction (Low-rise buildings) | | Concrete and wood frame construction techniques. Exterior walls have been finished with paint or stucco over time. | 1959-1961 | Medium |

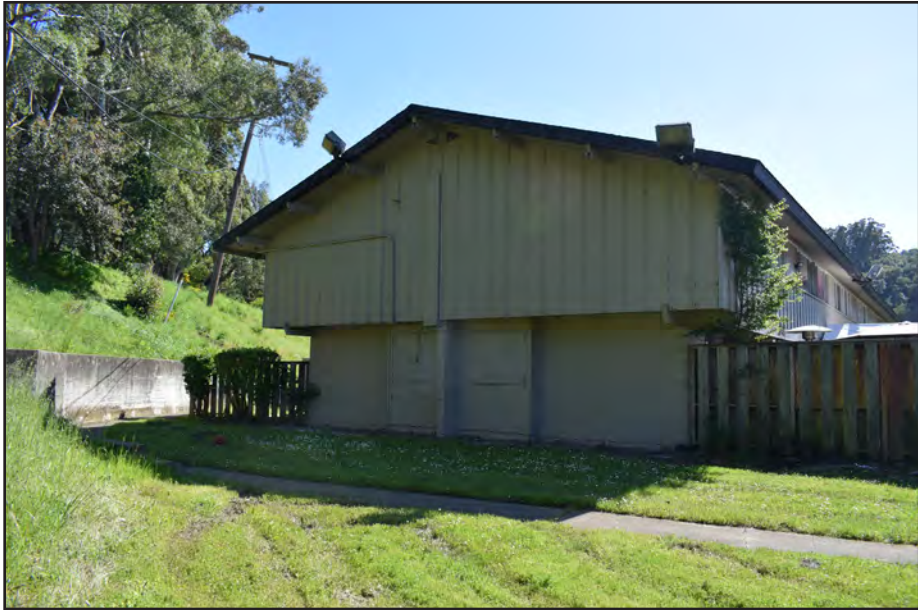
| Character Defining Features | Landscape Characteristic | Feature | Photo | Description | Date Built | Integrity |
|---|---|---|---|---|---|---|
| | Buildings and Structures | Redwood siding (Low-rise buildings) | | Redwood siding with vertical batten at building Type B. This feature has been painted over time. | 1959-1961 | Medium |

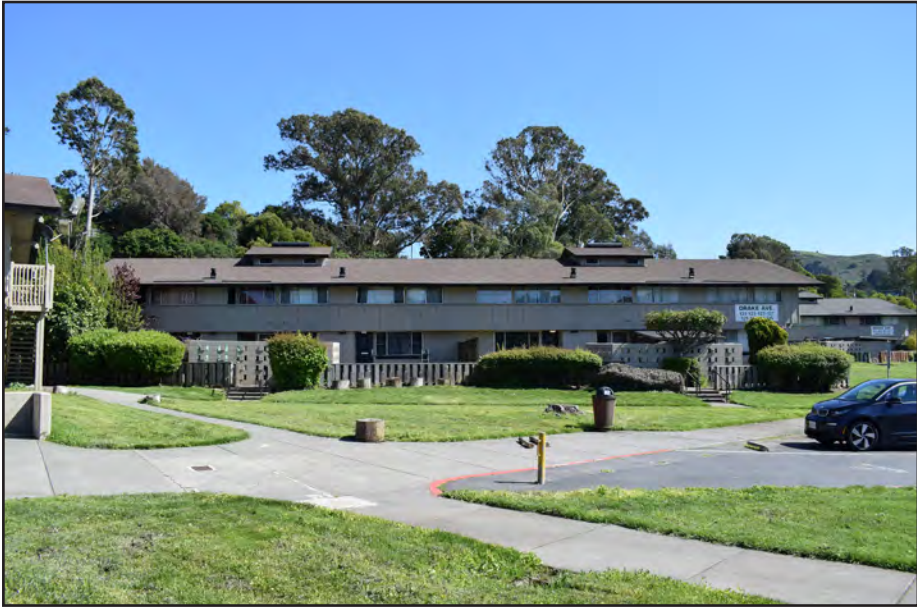
| Character Defining Features | Landscape Characteristic | Feature | Photo | Description | Date Built | Integrity |
|---|---|---|---|---|---|---|
| | Buildings and Structures | Location of fenestration (Low-rise buildings) | | The location of the doors and windows on the low-rise buildings, although some have been replaced over time. | 1959-1961 | Medium |

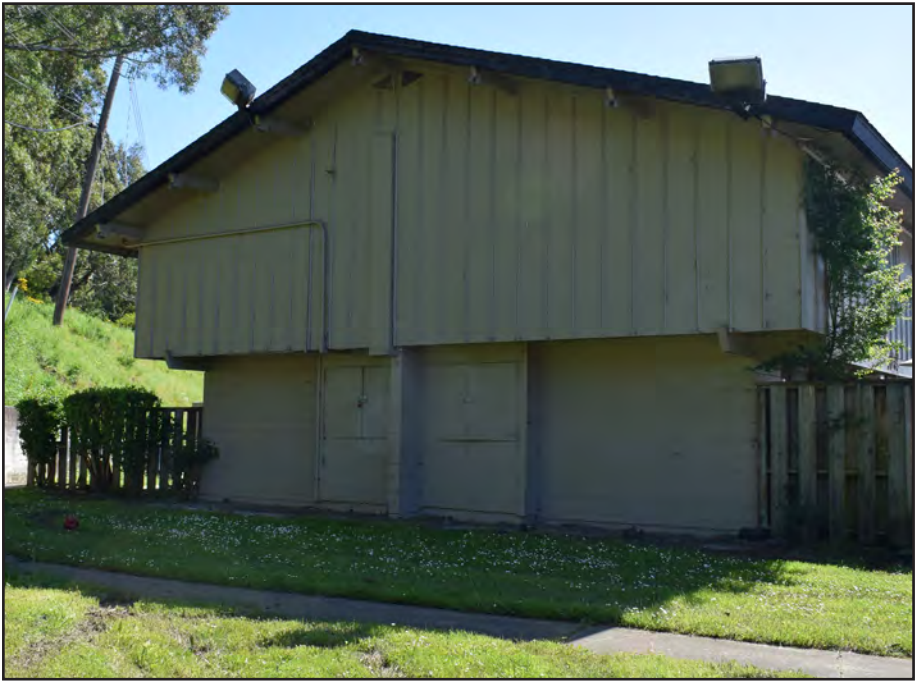
| Character Defining Features | Landscape Characteristic | Feature | Photo | Description | Date Built | Integrity |
|---|---|---|---|---|---|---|
| | Buildings and Structures | Utility boxes (Low-rise buildings) | | Enclosed utility boxes are located at one end of the low-rises. Some are in their historic condition; others have been replaced with updated enclosures. | 1959-1961 | Medium |

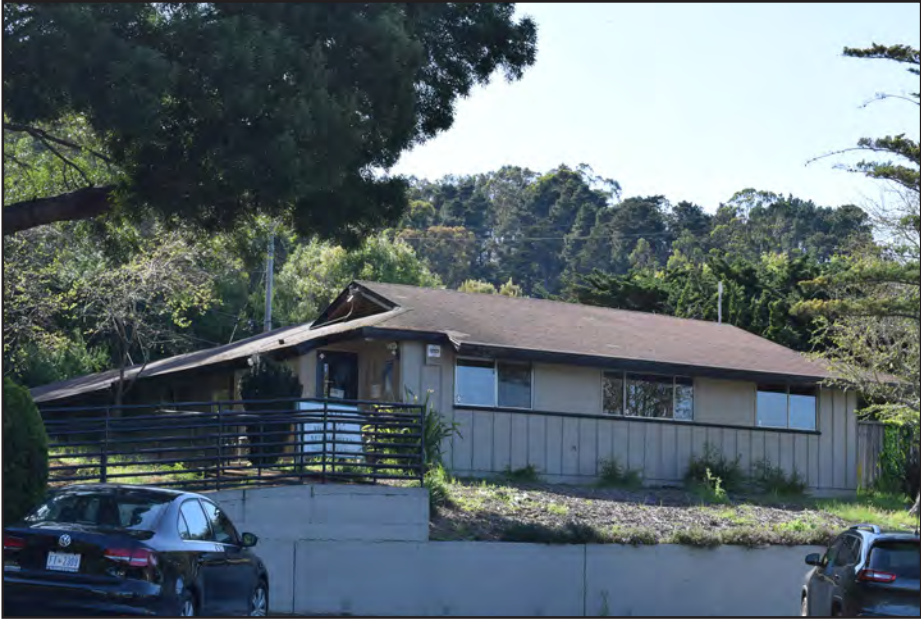
| Character Defining Features | Landscape Characteristic | Feature | Photo | Description | Date Built | Integrity |
|---|---|---|---|---|---|---|
| | Buildings and Structures | Admin building plan | | The L-shaped plan of the Administration and Maintenance building. The building's plan was altered in 1985 via a reconfigured entry and a rear addition. | 1959-1961 | Medium |

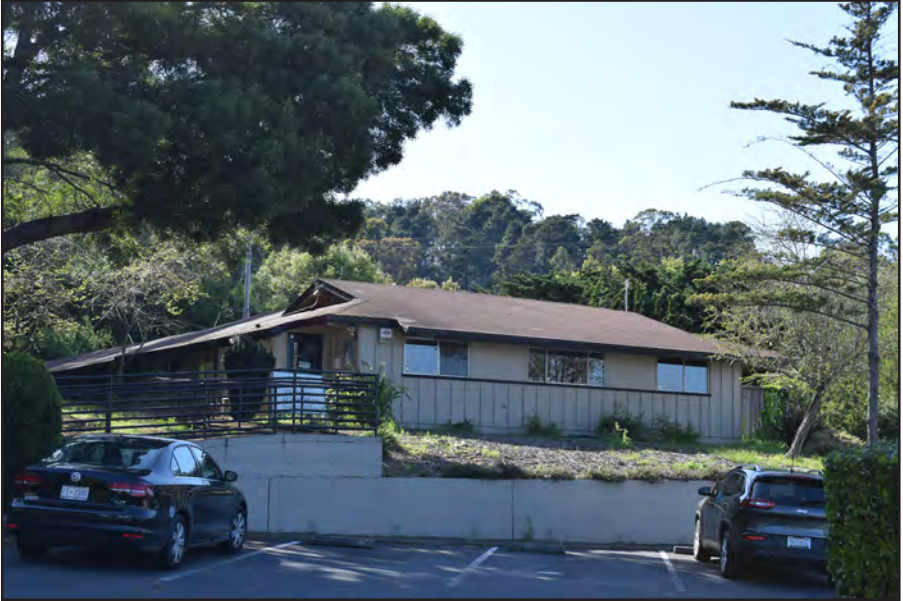
| Character Defining Features | Landscape Characteristic | Feature | Photo | Description | Date Built | Integrity |
|---|---|---|---|---|---|---|
| | Buildings and Structures | Cross-hip roof (Admin building) | | The Administration and Maintenance building has been altered and re-clad overtime but maintains its general form. | 1959-1961 | Medium |

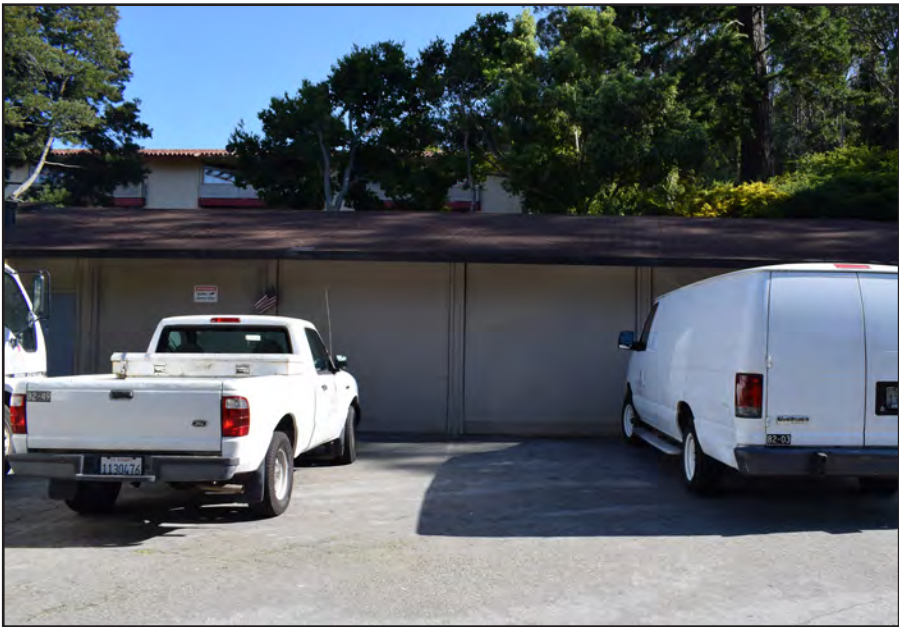
| Character Defining Features | Landscape Characteristic | Feature | Photo | Description | Date Built | Integrity |
|---|---|---|---|---|---|---|
| | Buildings and Structures | Location of garage doors (Admin building) | | The location of four garage doors along the rear wing of the Administration and Maintenance building. The doors have been replaced. | 1959-1961 | High |
