# **CHARACTER-DEFINING FEATURE STUDY**

## **GOLDEN GATE VILLAGE, MARIN CITY, CA**

**September 2019**

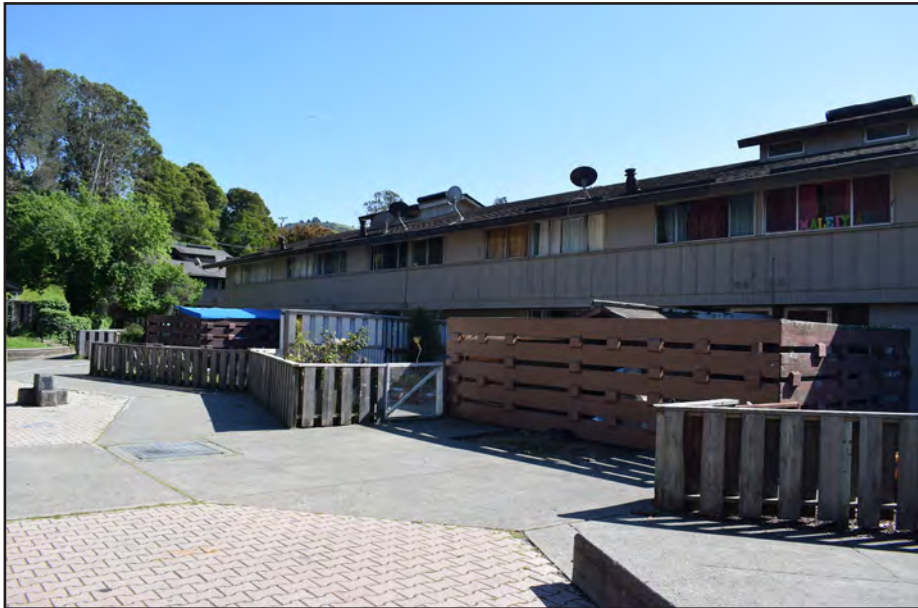
| Character Defining Features | Landscape Characteristic | Feature | Photo | Description | Date Built | Integrity |
|---|---|---|---|---|---|---|
| | Spatial Organization | Private/Public outdoor space | | Both private outdoor space (terraces or balconies) and shared gathering outdoor spaces. | 1959 | Medium |
| | | | | | 1992 | Good |

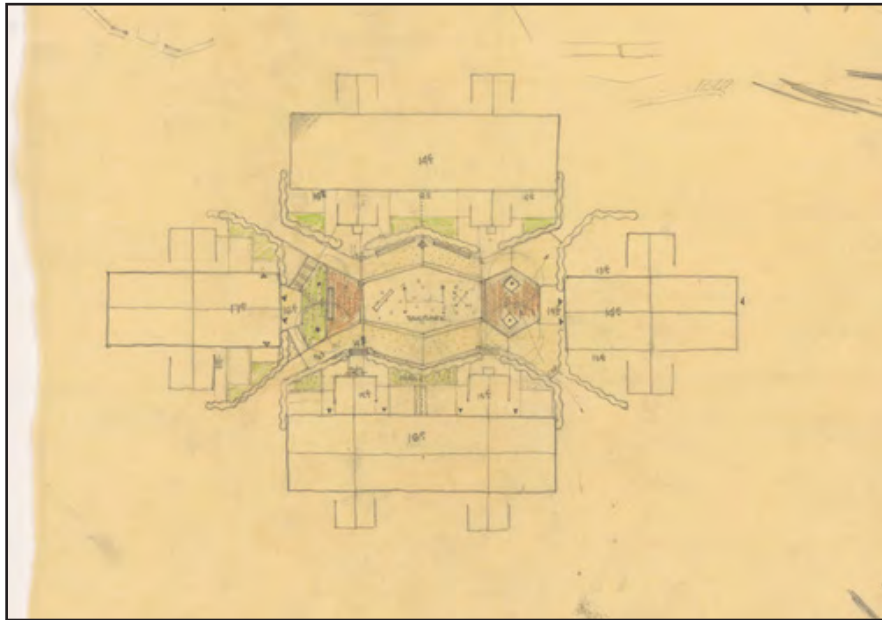
| Character Defining Features | Landscape Characteristic | Feature | Photo | Description | Date Built | Integrity |
|---|---|---|---|---|---|---|
| | Spatial Organization | Shared outdoor areas | | Interspersed shared areas: courtyards, terraces, parking, play areas. | 1959 | Medium |
| | | | | | 1992 | Fair |

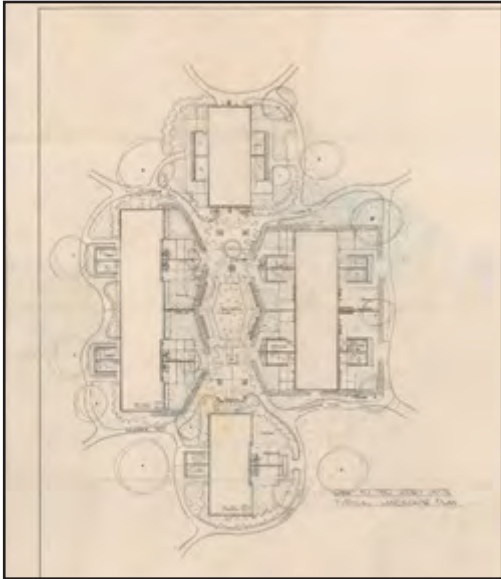
| Character Defining Features | Landscape Characteristic | Feature | Photo | Description | Date Built | Integrity |
|---|---|---|---|---|---|---|
| | Spatial Organization | Organization of the low-rise buildings | | Low-rise buildings oriented in varying directions with three clusters, each quadrilaterally arranged around a courtyard. | 1959-1961 | High |
| | | | | | N/A | Good |

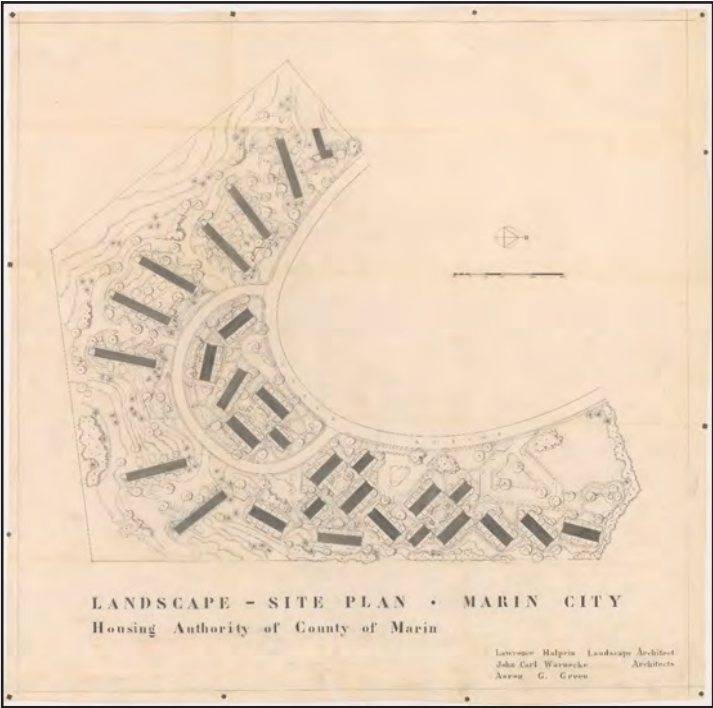
| Character Defining Features | Landscape Characteristic | Feature | Photo | Description | Date Built | Integrity |
|---|---|---|---|---|---|---|
| | Spatial Organization | Organization of the high-rise buildings | | High-rise buildings arranged in a radial pattern, emerging from the hillside so that each retains its relationship at 90-degrees to the contours. | 1959-1961 | High |
| | | | | | N/A | Good |

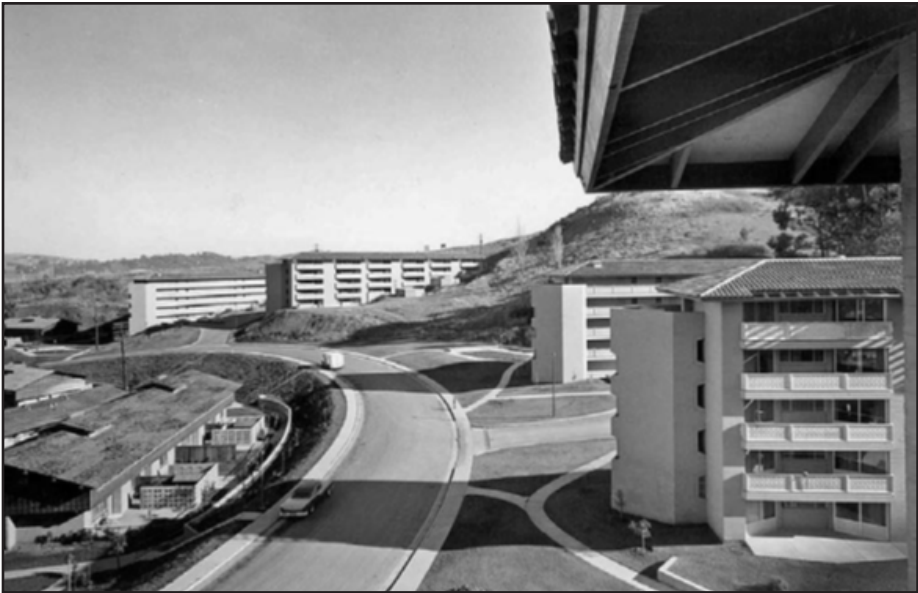
| Character Defining Features | Landscape Characteristic | Feature | Photo | Description | Date Built | Integrity |
|---|---|---|---|---|---|---|
| | Cluster Arrangement | High-rise cluster | <p>Source: Ruark, 2017.</p> | The location, design and spatial organization of the high-rise cluster. | 1959-1961 | High |
| | | | | | N/A | Good |

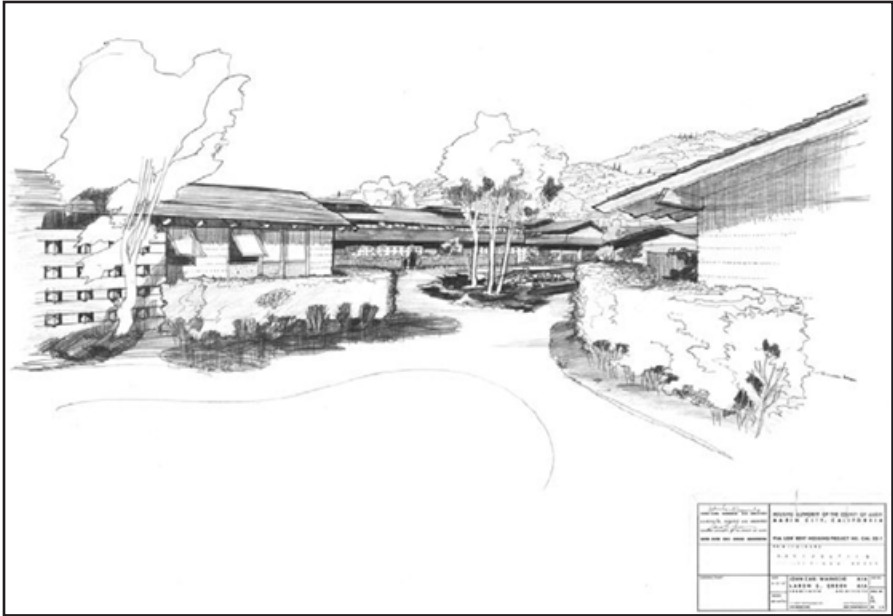
| Character Defining Features | Landscape Characteristic | Feature | Photo | Description | Date Built | Integrity |
|---|---|---|---|---|---|---|
| | Cluster Arrangement | Low-rise cluster | <p>Source: Ruark, 2017.</p> | The location, design and spatial organization of the low-rise cluster. | 1959-1961 | High |
| | | | | | N/A | Good |

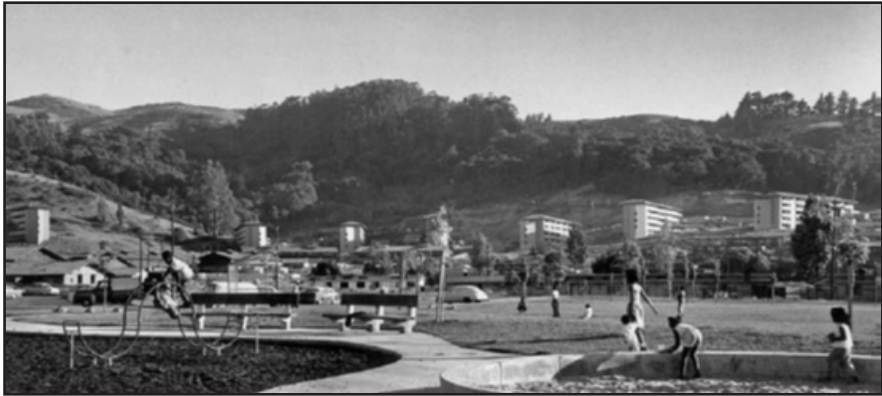
| Character Defining Features | Landscape Characteristic | Feature | Photo | Description | Date Built | Integrity |
|---|---|---|---|---|---|---|
| | Cluster Arrangement | Location of the recreation cluster | | The location of the Recreation cluster. The design and spatial arrangement have been altered. | 1959-1961 | Medium |
| | | | | | 1992 | Good |

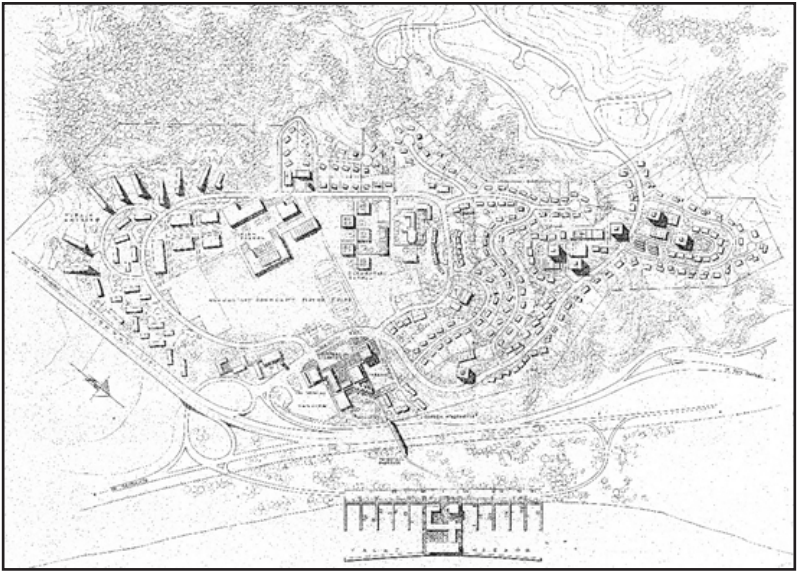
| Character Defining Features | Landscape Characteristic | Feature | Photo | Description | Date Built | Integrity |
|---|---|---|---|---|---|---|
| | Land Use | Multi-family residential use | | <p>28 out of the 29 buildings at the property were designed for multi-family residential use. Building B-12 was converted to commercial use in 1985. This 1959 image from the Marin City Redevelopment project shows Golden Gate Village on the left end labeled as “Public Housing.”</p> | 1959-1961 | Medium |
| | | | | | 1985 | Good |

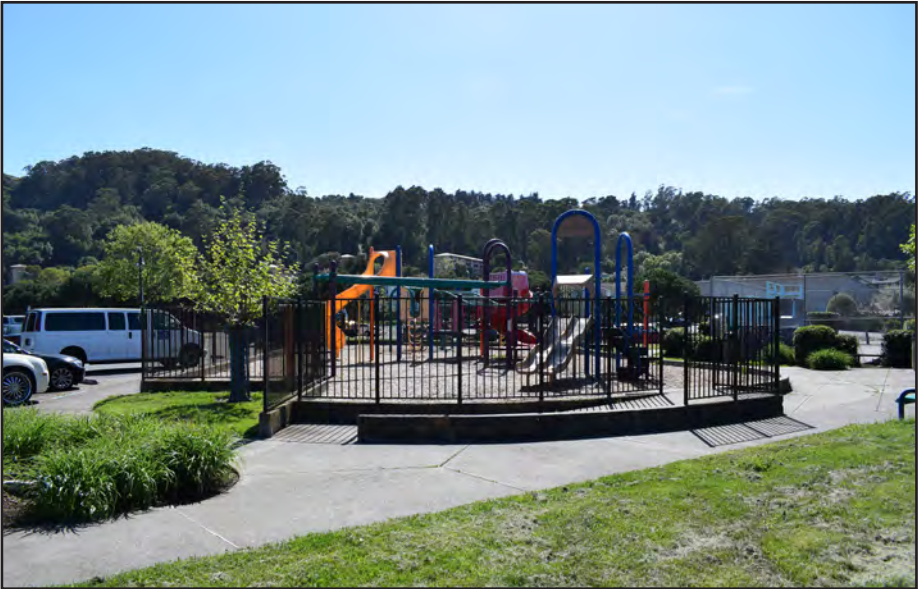
| Character Defining Features | Landscape Characteristic | Feature | Photo | Description | Date Built | Integrity |
|---|---|---|---|---|---|---|
| | Land Use | Community gathering spaces | | Shared spaces (courtyards, terraces, play grounds, recreational fields) were intended to create a sense of community for tenants who lived at the property. | 1959-1961 | Medium |
| | | | | | 1992 | Good |

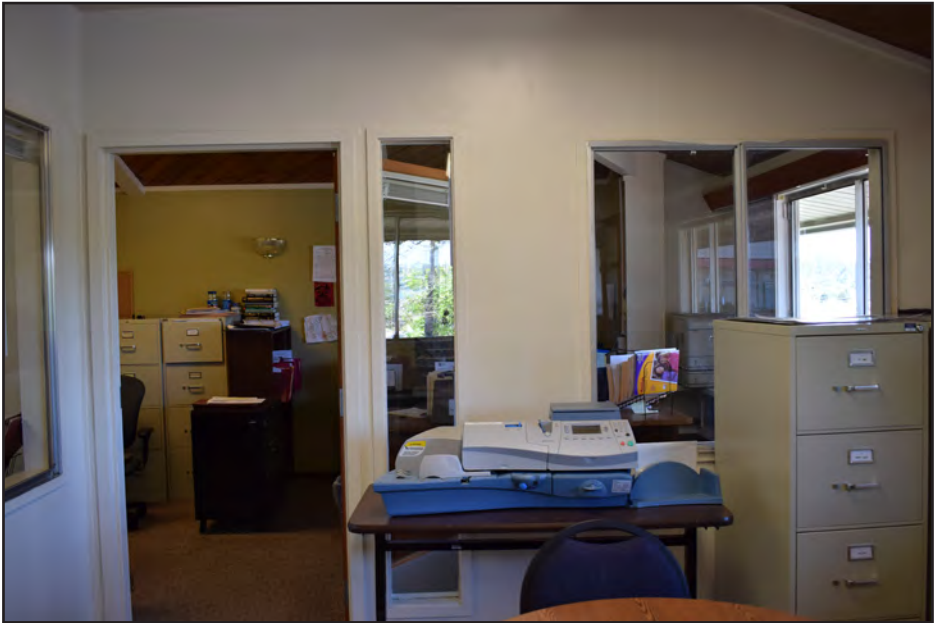
| Character Defining Features | Landscape Characteristic | Feature | Photo | Description | Date Built | Integrity |
|---|---|---|---|---|---|---|
| | Land Use | Administration and maintenance use | | The Admin building was built to house MHA's central administration offices and maintenances facilities for Golden Gate Village. MHA moved their central offices off-site in the 1990s, but the building still houses administrative offices and maintenance facilities for Golden Gate Village. | 1959-1961 | Medium |
| | | | | | 1900s | Fair |

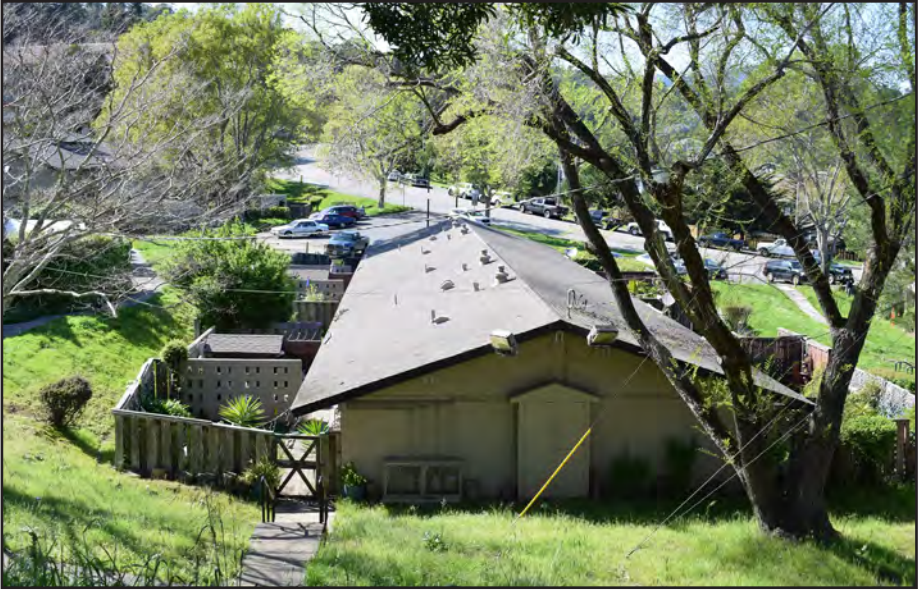
| Character Defining Features | Landscape Characteristic | Feature | Photo | Description | Date Built | Integrity |
|---|---|---|---|---|---|---|
| | Topography | Graded benches | | The series of graded benches for buildings in semicircle area and buildings B5, E2, and C2, and sloped areas between these benches. | 1959-1961 | Medium |
| | | | | | N/A | Fair |

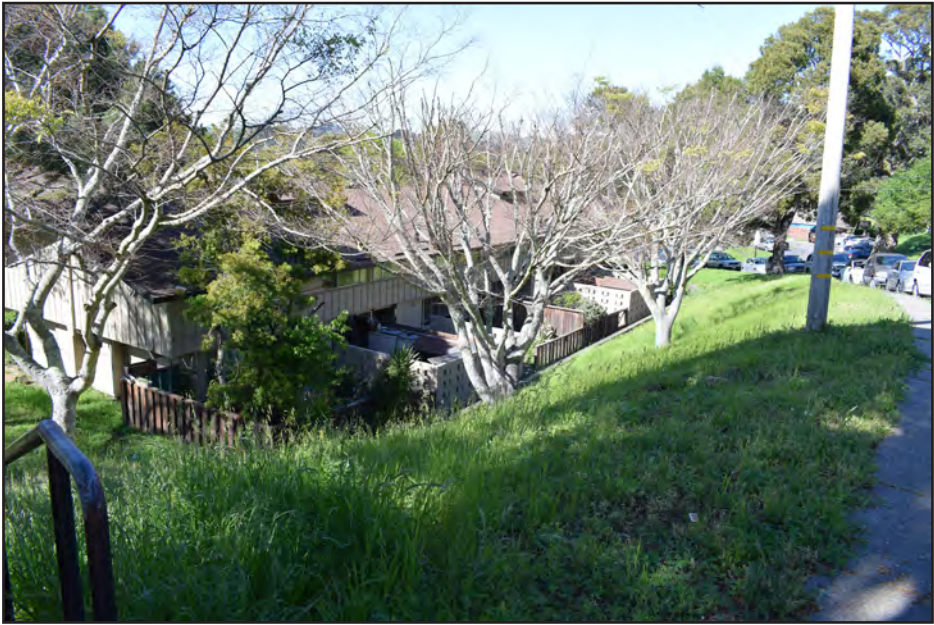
| Character Defining Features | Landscape Characteristic | Feature | Photo | Description | Date Built | Integrity |
|---|---|---|---|---|---|---|
| | Topography | Graded slope in the semi-circle | | The graded slope along Cole Drive in the semi-circle area. | 1959-1961 | High |
| | | | | | N/A | Good |

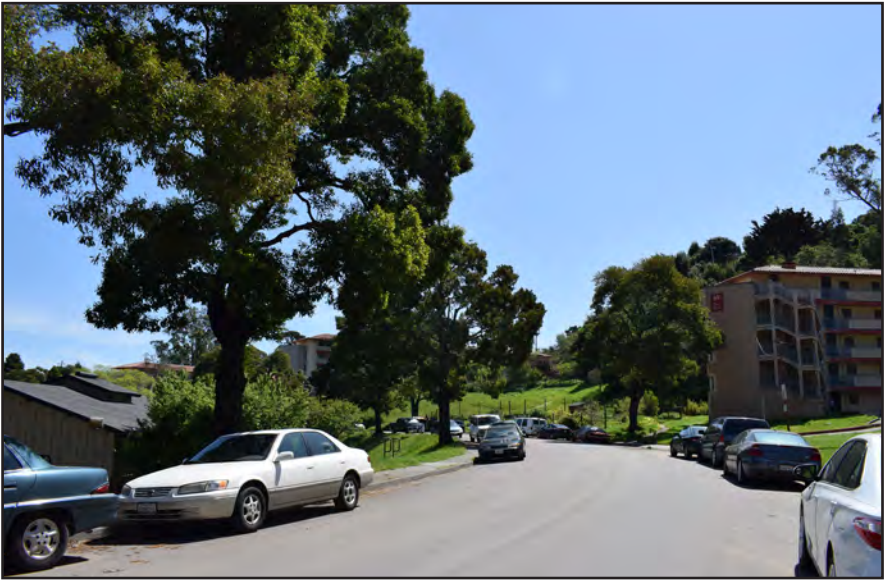
| Character Defining Features | Landscape Characteristic | Feature | Photo | Description | Date Built | Integrity |
|---|---|---|---|---|---|---|
| | Circulation | U-shape of Cole Drive | | The U-shaped alignment of Cole Drive. | 1955 | High |
| | | | | | N/A | Good |

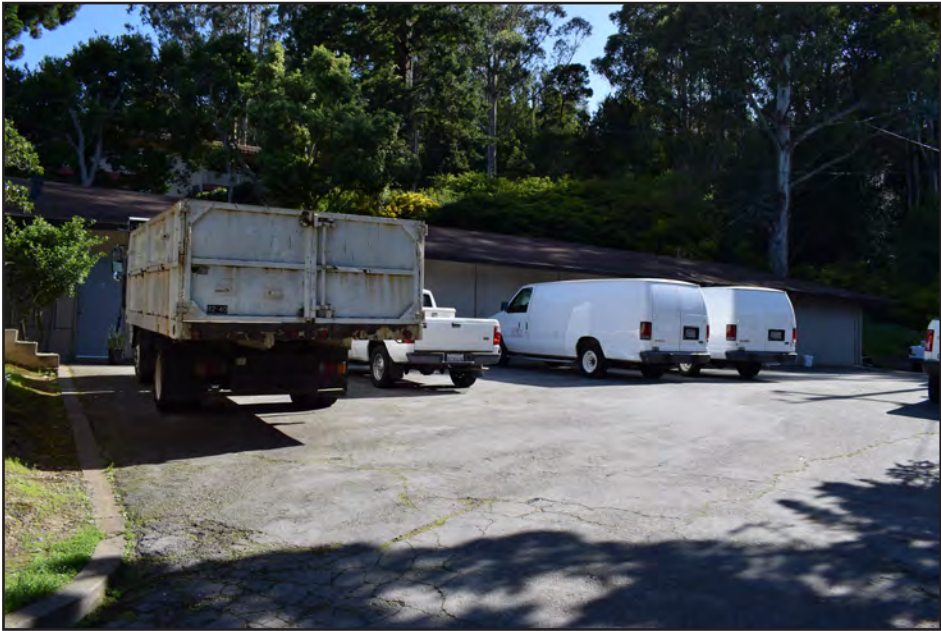
| Character Defining Features | Landscape Characteristic | Feature | Photo | Description | Date Built | Integrity |
|---|---|---|---|---|---|---|
| | Circulation | Maintenance Service Road | | The alignment of the Maintenance Service Road adjacent to the Administration building. | 1959-1961 | High |
| | | | | | 1985 | Good |

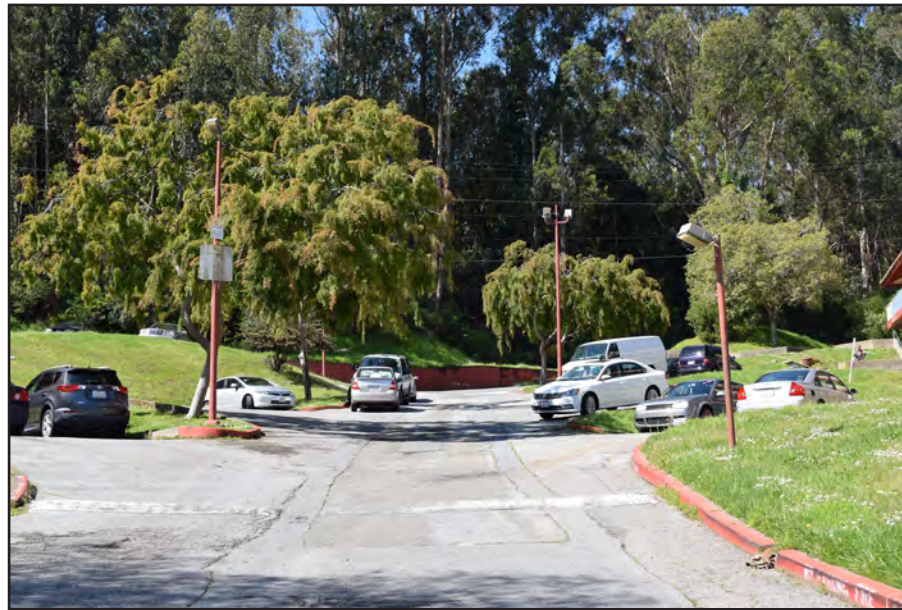
| Character Defining Features | Landscape Characteristic | Feature | Photo | Description | Date Built | Integrity |
|---|---|---|---|---|---|---|
| | Circulation | Four driveways with parking terraces | | The alignment of the four driveways with parking terraces in the high-rise cluster, between Buildings 49-79, that connect Cole Drive to the Service Road. | 1959-1961 | Medium |
| | | | | | 1993 | Fair |

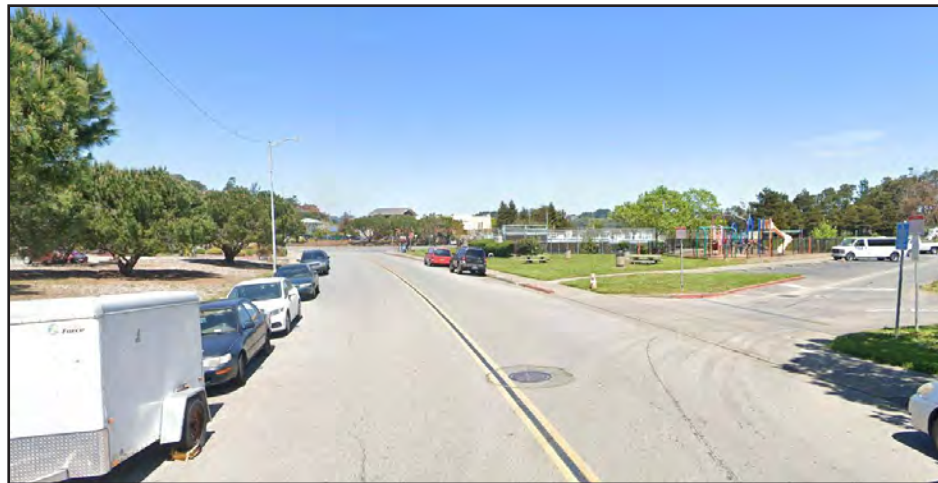
| Character Defining Features | Landscape Characteristic | Feature | Photo | Description | Date Built | Integrity |
|---|---|---|---|---|---|---|
| | Circulation | Primary access from Drake Avenue | | Primary access to the property is provided via Drake Avenue. The alignment was adjusted in 1992. | 1959-1961 | Medium |
| 1992 | | | | | Good | |

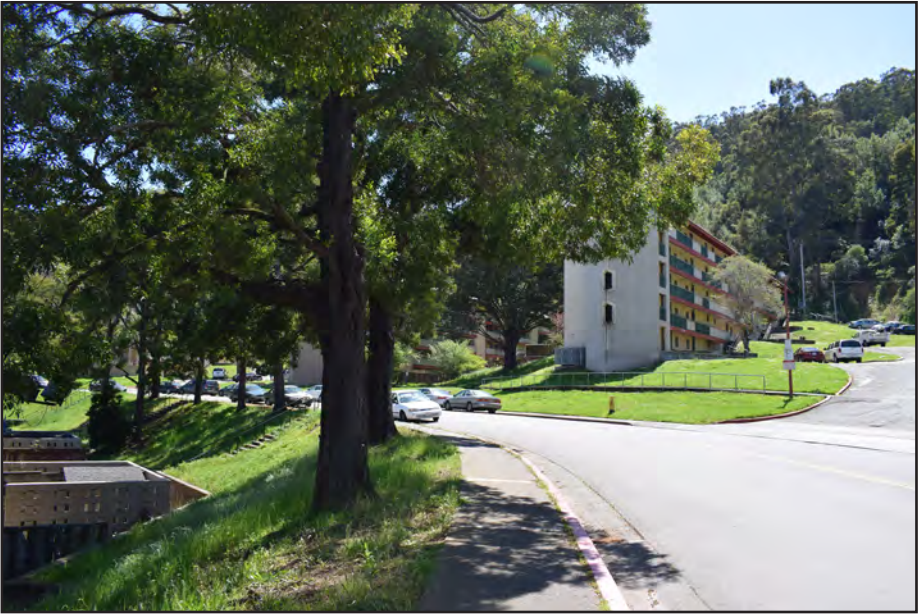
| Character Defining Features | Landscape Characteristic | Feature | Photo | Description | Date Built | Integrity |
|---|---|---|---|---|---|---|
| | Circulation | Concrete sidewalks | | The material and alignment of concrete sidewalks along south side of Drake Avenue and both sides of Cole Drive. | 1959-1961 | Medium |
| | | | | | 1984 | Fair |

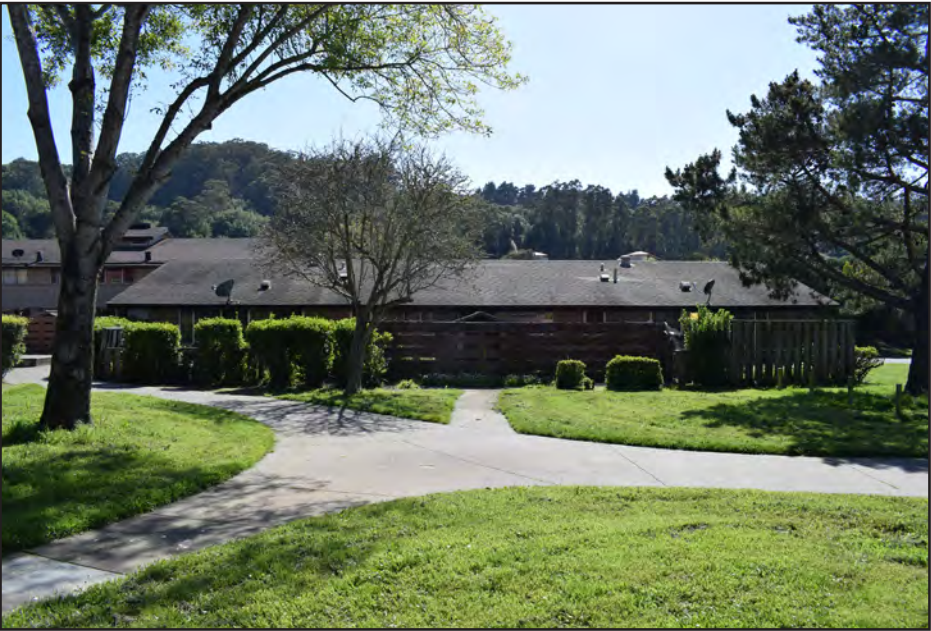
| Character Defining Features | Landscape Characteristic | Feature | Photo | Description | Date Built | Integrity |
|---|---|---|---|---|---|---|
| | Circulation | Curvilinear concrete sidewalks | | The materiality and curvilinear design of concrete sidewalks meandering throughout the entirety of the site. | 1959-1961 | Medium |
| | | | | | 1984 | Fair |

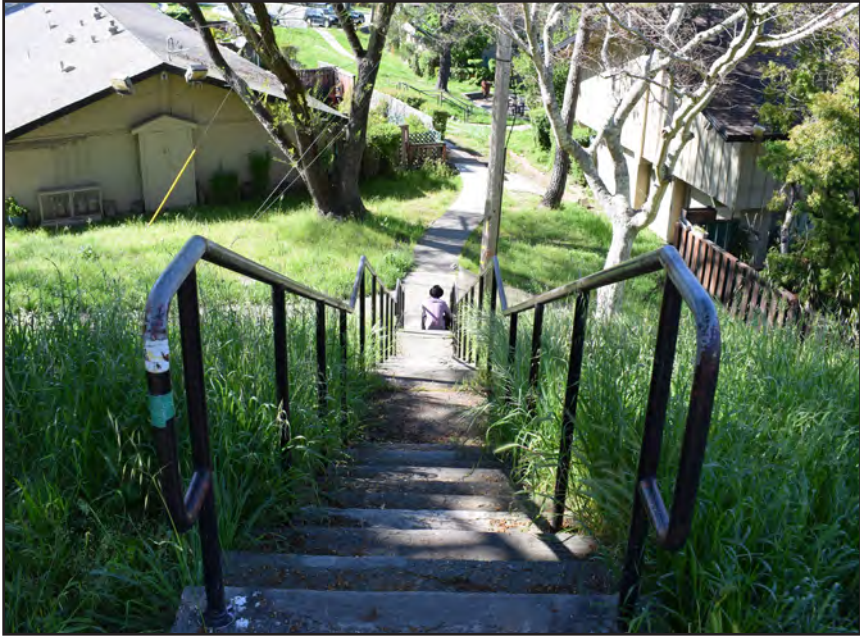
| Character Defining Features | Landscape Characteristic | Feature | Photo | Description | Date Built | Integrity |
|---|---|---|---|---|---|---|
| | Circulation | Staircases | | The alignment of concrete staircases built into the site's steep topography. | 1959-1961 | High |
| | | | | | N/A | Fair |

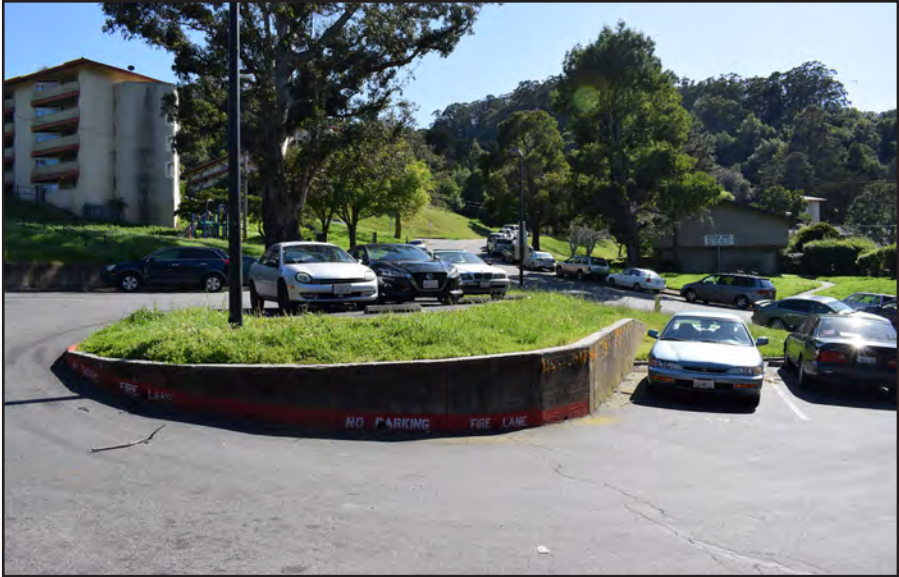
| Character Defining Features | Landscape Characteristic | Feature | Photo | Description | Date Built | Integrity |
|---|---|---|---|---|---|---|
| | Circulation | Parking Lots | | Five triangle-shaped parking lots with center vegetated islands. | 1959-1961 | Medium |
| | | | | | 1965, 1984, 1993, 2004 | Fair |

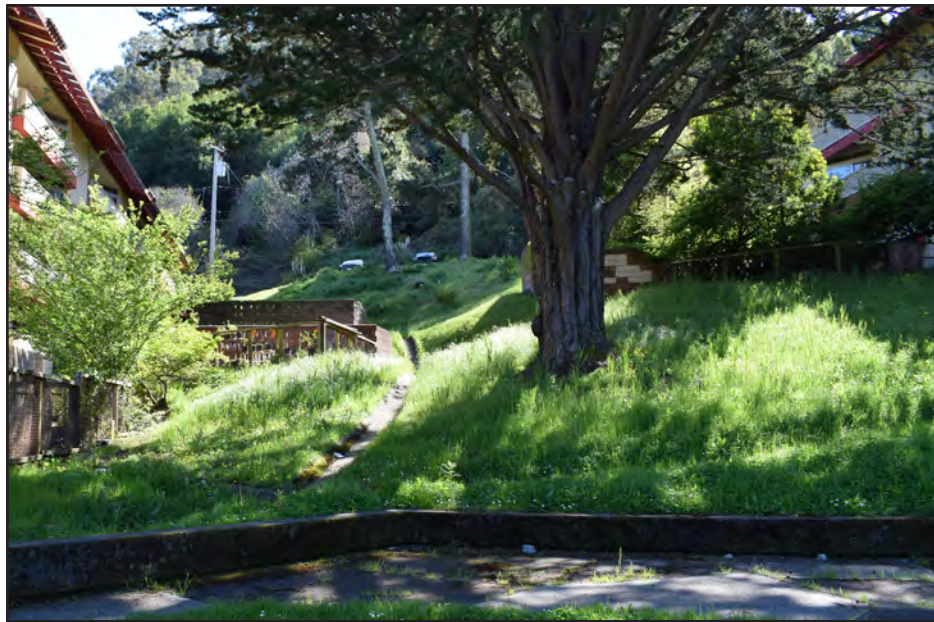
| Character Defining Features | Landscape Characteristic | Feature | Photo | Description | Date Built | Integrity |
|---|---|---|---|---|---|---|
| | Vegetation | Lawn ground cover character | | Lawn ground cover character (rough character in high-rise cluster and more manicured character in low-rise and recreation area clusters). | 1959-1961 | Medium |
| | | | | | 1974, 1979, 1984, 1985 | Fair |

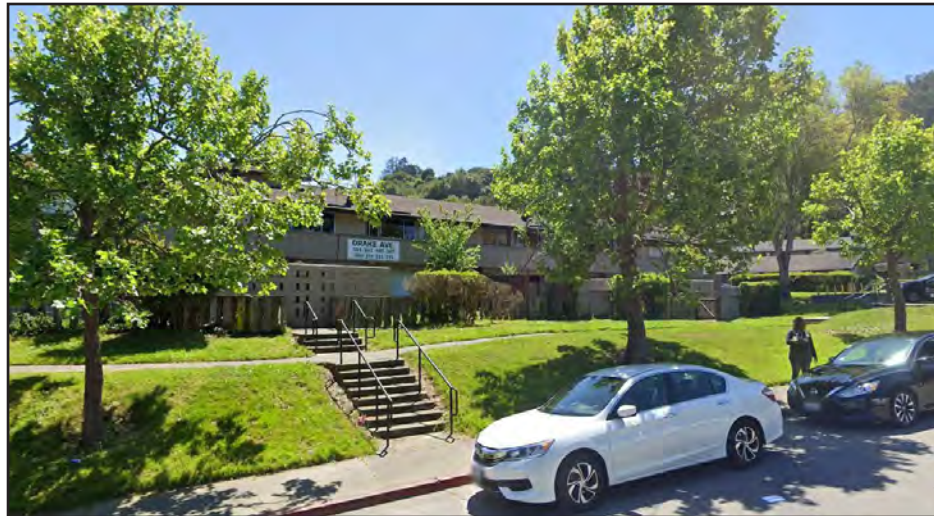
| Character Defining Features | Landscape Characteristic | Feature | Photo | Description | Date Built | Integrity |
|---|---|---|---|---|---|---|
| | Vegetation | Street trees along semi-circle area | | Row of London plane trees ( <i>Platanus acerifolia</i> ) along south side of Drake Avenue within bounds of semi-circle area (between intersections of Cole Drive). | 1959-1961 | Medium |
| | | | | | N/A | Fair |

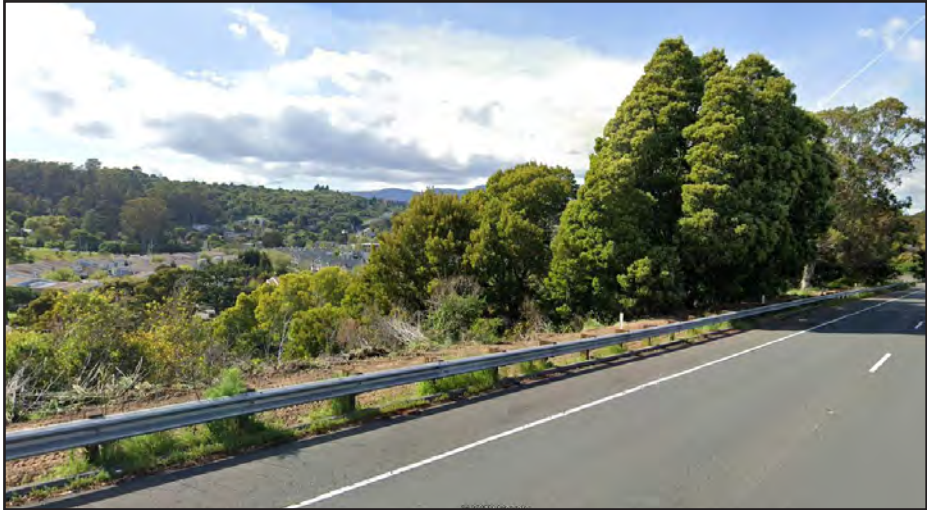
| Character Defining Features | Landscape Characteristic | Feature | Photo | Description | Date Built | Integrity |
|---|---|---|---|---|---|---|
| | Vegetation | Buffer along U.S. HW 101 | | Densely planted buffer including groupings of trees, shrubs and a groundcover along eastern boundary of property along Highway 101. Image is looking northwest from U.S. HW 101 into Golden Gate Village with vegetated buffer. | 1959-1961 | Medium |
| | | | | | 1979 | Fair |

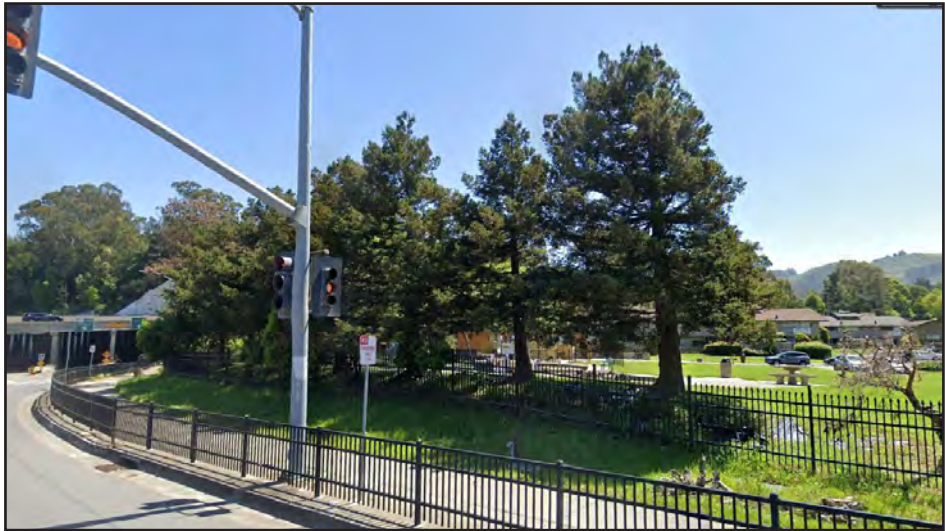
| Character Defining Features | Landscape Characteristic | Feature | Photo | Description | Date Built | Integrity |
|---|---|---|---|---|---|---|
| | Vegetation | Row of coniferous trees along northern property boundary | | Dense row of coniferous trees along northern edge of recreation area (where remaining). Image is looking southeast into Golden Gate Village site from north of site boundary. | 1974 | Medium |
| | | | | | 1992 | Good |

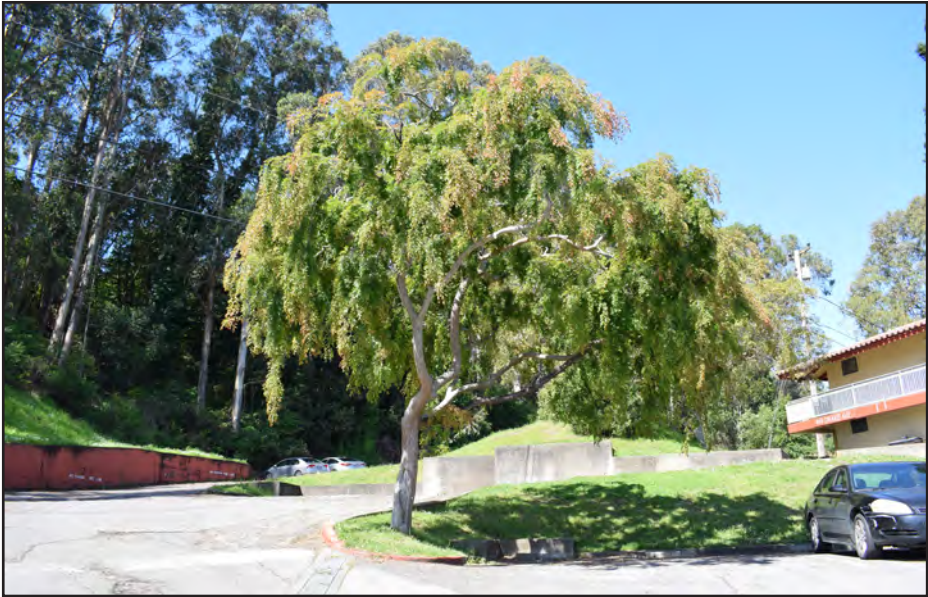
| Character Defining Features | Landscape Characteristic | Feature | Photo | Description | Date Built | Integrity |
|---|---|---|---|---|---|---|
| | Vegetation | Elm and Plum trees along driveways | | Chinese Elm ( <i>Ulmus parvifolia</i> ) and species of Plum trees alternating along length of driveways in high-rise cluster. | 1974 | High |
| | | | | | N/A | Good |

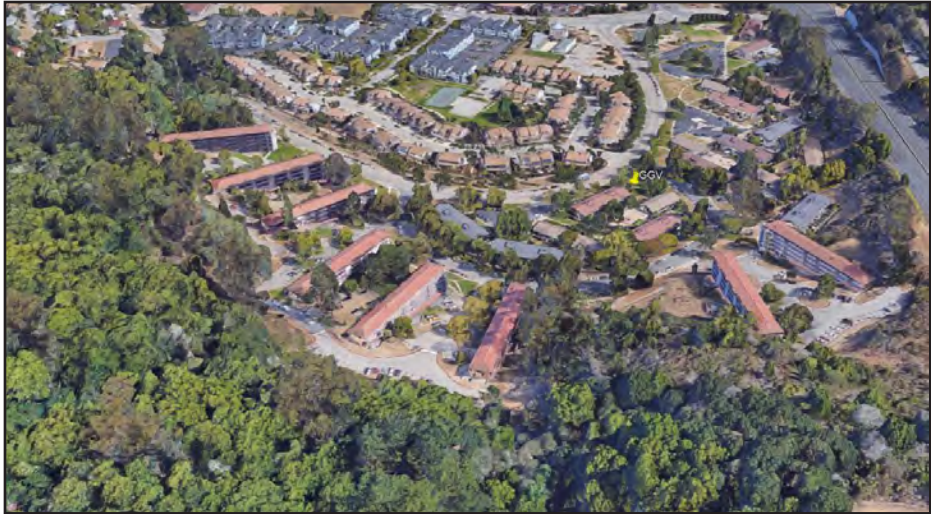
| Character Defining Features | Landscape Characteristic | Feature | Photo | Description | Date Built | Integrity |
|---|---|---|---|---|---|---|
| | Vegetation | Tree and shrub cover along south and southwest of site | <p>Source: Google Earth Pro, 2019.</p> | Dense tree and shrub cover along the southern and southwestern edges of the site, where the property shares a boundary with GGNRA, and extending southward between buildings 69 and 59, extending the feeling of a woodland setting from the Marin Headlands. The image shows the tree and shrub cover south and southwest of the site that extends from this shared boundary. | 1959-1961 | Medium |
| | | | | | 1974 | Fair |

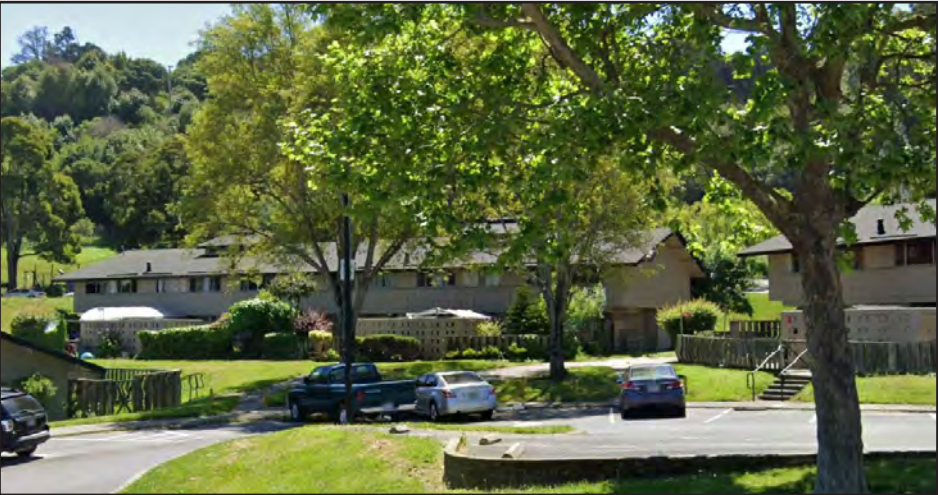
| Character Defining Features | Landscape Characteristic | Feature | Photo | Description | Date Built | Integrity |
|---|---|---|---|---|---|---|
| | Vegetation | Vegetation within fenced enclosures of tenants | | Vegetation located within fenced enclosures of low-rise building units unique to each tenant. The image shows tenant gardens located within the fence enclosures, which was intended by the landscape architect. | 1961 | Medium |
| | | | | | On-going | Fair |

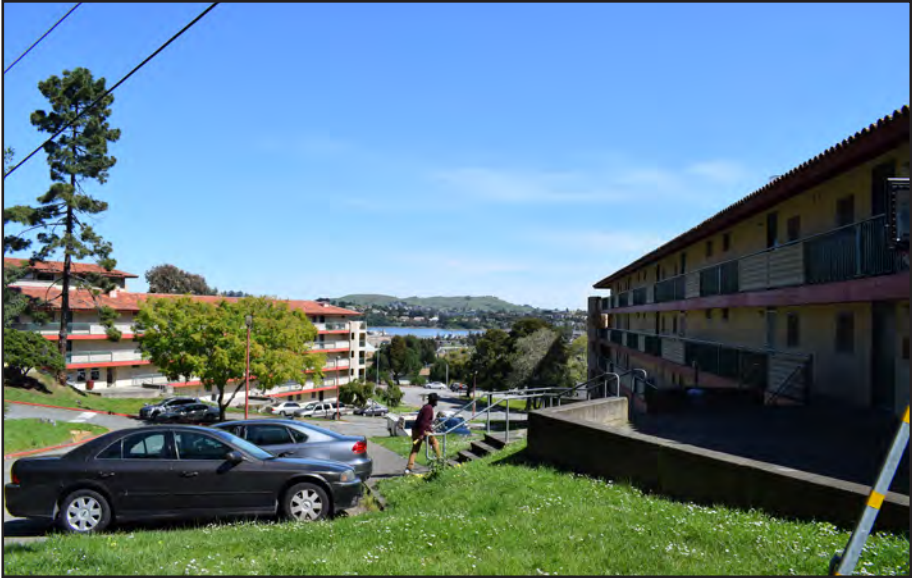
| Character Defining Features | Landscape Characteristic | Feature | Photo | Description | Date Built | Integrity |
|---|---|---|---|---|---|---|
| | Views and Vistas | Views of Richardson Bay and tidal marshes | | Views towards Richardson Bay and tidal marshes in the north and east. | 1959-1961 | High |
| | | | | | N/A | Good |

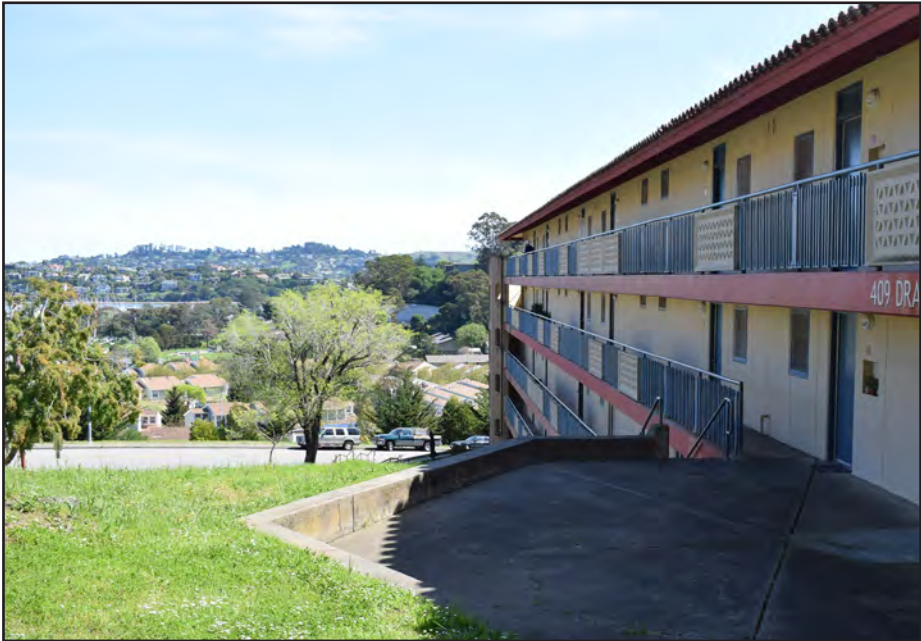
| Character Defining Features | Landscape Characteristic | Feature | Photo | Description | Date Built | Integrity |
|---|---|---|---|---|---|---|
| | Views and Vistas | Views of suburban development | | Views of the surrounding suburban development to the north and east. | 1959-1961 | High |
| | | | | | N/A | Good |

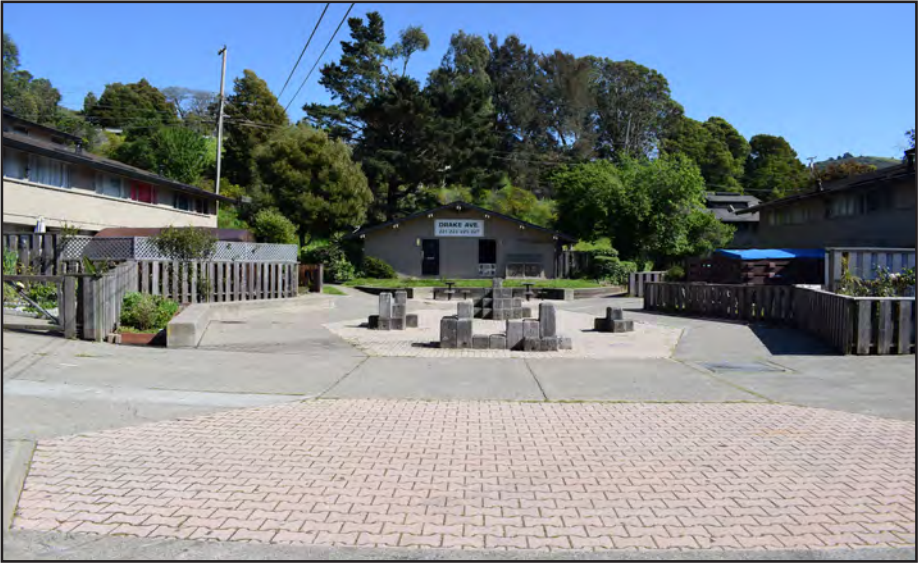
| Character Defining Features | Landscape Characteristic | Feature | Photo | Description | Date Built | Integrity |
|---|---|---|---|---|---|---|
| | Views and Vistas | Vistas at shared courtyards | | Framed vistas in and out of shared courtyards are extant, but have been altered by changes to small scale features and vegetation in the courtyard areas. | 1959-1961 | Medium |
| | | | | | 1974, 1984 | Fair |

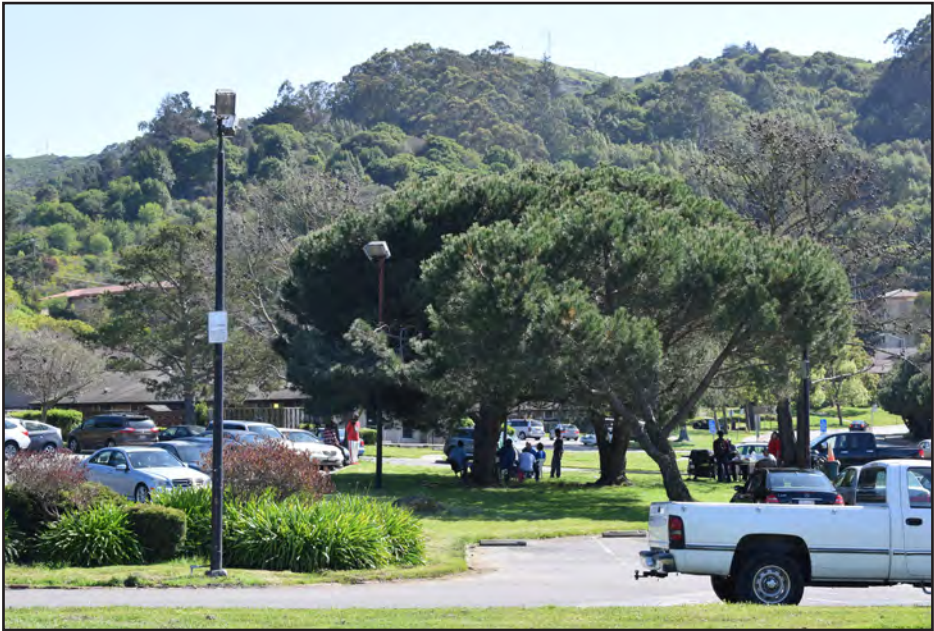
| Character Defining Features | Landscape Characteristic | Feature | Photo | Description | Date Built | Integrity |
|---|---|---|---|---|---|---|
| | Views and Vistas | Long view toward high-rise buildings | | Broad views from the recreation area cluster towards the high-rise cluster. | 1959-1961 | High |
| | | | | | N/A | Good |

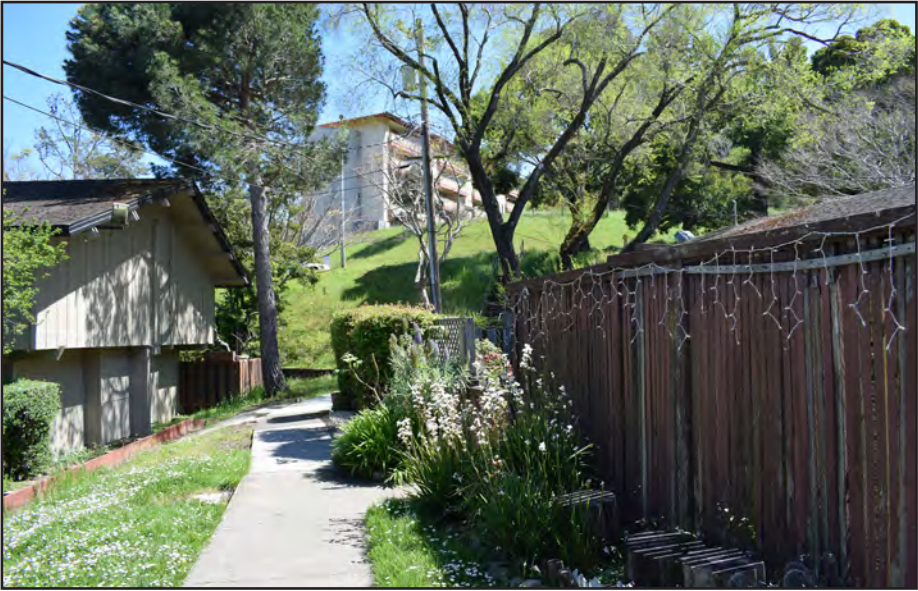
| Character Defining Features | Landscape Characteristic | Feature | Photo | Description | Date Built | Integrity |
|---|---|---|---|---|---|---|
| | Views and Vistas | Mid-range views towards high-rise buildings | | Broad views from the low-rise cluster towards the high-rise cluster. | 1959-1961 | High |
| | | | | | N/A | Good |

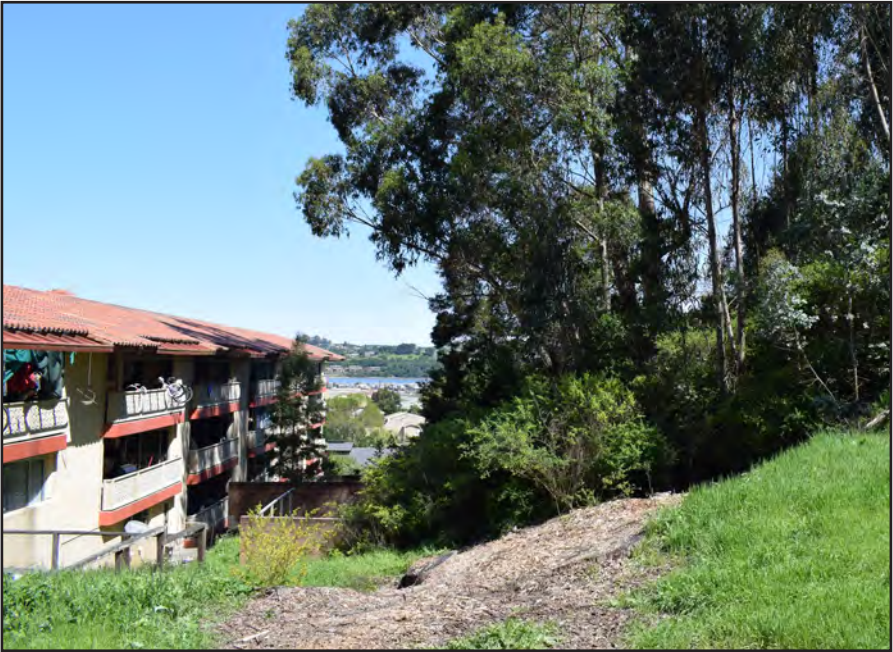
| Character Defining Features | Landscape Characteristic | Feature | Photo | Description | Date Built | Integrity |
|---|---|---|---|---|---|---|
| | Views and Vistas | Long views towards recreation cluster | | Views from the high-rise cluster over the low-rise buildings towards the recreation area cluster. Alterations to the recreation cluster have resulted in changes to this viewshed. | 1959-1961 | Medium |
| | | | | | 1974, 1992 | Good |

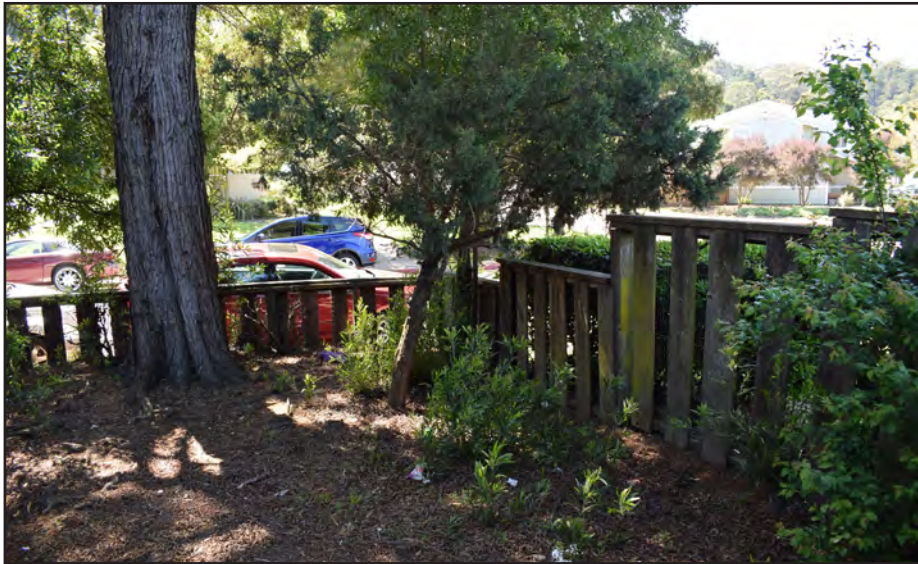
| Character Defining Features | Landscape Characteristic | Feature | Photo | Description | Date Built | Integrity |
|---|---|---|---|---|---|---|
| | Views and Vistas | Constrained views from private patios | | Views within tenants' private patios in the low-rise buildings constrained from privacy screens using fences and vegetation. Tenants have altered the vegetation over-time, in keeping with the original intention of the landscape architect. | 1959-1961 | High |
| | | | | | On-going | Good |

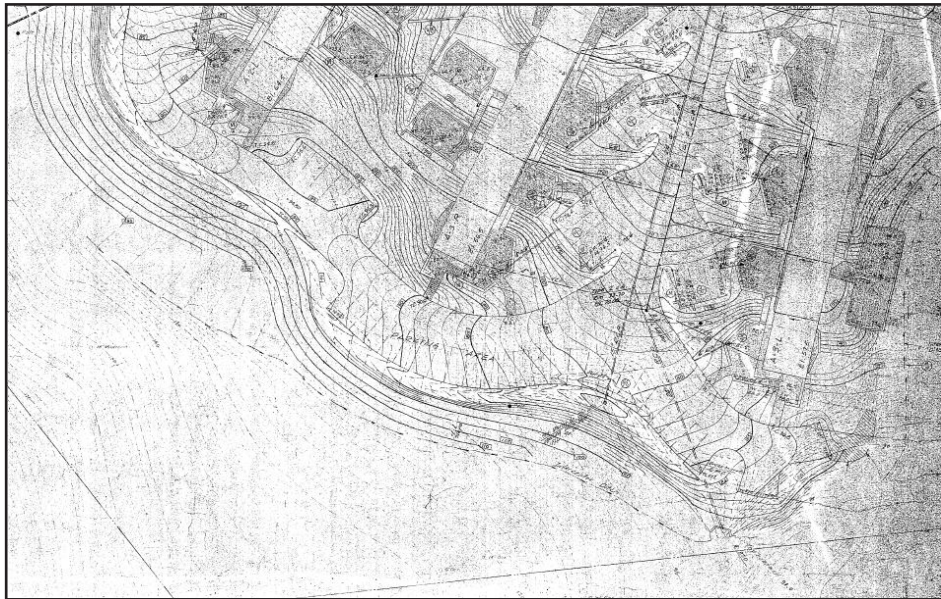
| Character Defining Features | Landscape Characteristic | Feature | Photo | Description | Date Built | Integrity |
|---|---|---|---|---|---|---|
| | Constructed Water Feature | Unlined interceptor ditch | | Unlined interceptor ditch located in sloped area south of Service Rd and east of building 69 Cole Drive along the flood zone area. The image is a portion of the 1959 civil plan showing the location of the unlined interceptor ditch along the southern slope. | 1959-1961 | High |
| | | | | | N/A | Fair |

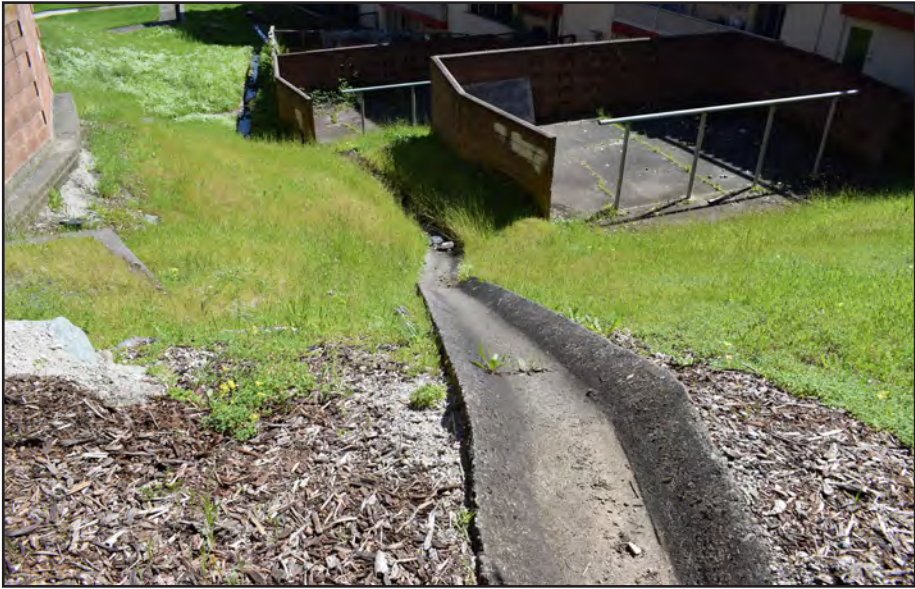
| Character Defining Features | Landscape Characteristic | Feature | Photo | Description | Date Built | Integrity |
|---|---|---|---|---|---|---|
| | Constructed Water Feature | Concrete lined interceptor ditches | | Concrete lined interceptor ditches located in the open grassy sloped areas between the high-rise buildings that do not have a driveway between them. | 1959-1961 | High |
| | | | | | N/A | Good |
