# **CHARACTER-DEFINING FEATURE STUDY**

## **GOLDEN GATE VILLAGE, MARIN CITY, CA**

**September 2019**

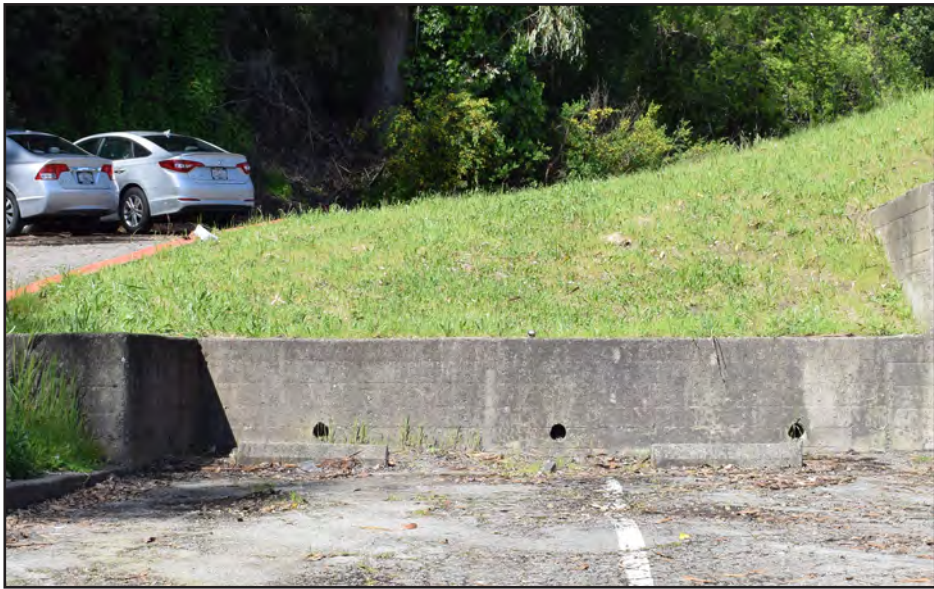
| Character Defining Features | Landscape Characteristic | Feature | Photo | Description | Date Built | Integrity |
|---|---|---|---|---|---|---|
| | Constructed Water Feature | Retaining wall weep holes | | Weep holes located on retaining walls and other masonry features. | 1959-1961 | High |
| | | | | | N/A | Good |

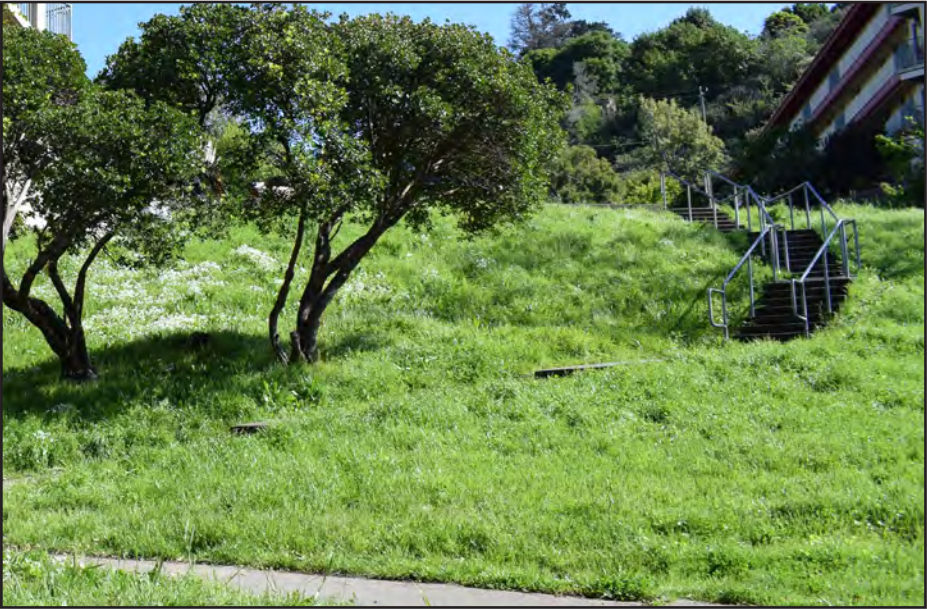
| Character Defining Features | Landscape Characteristic | Feature | Photo | Description | Date Built | Integrity |
|---|---|---|---|---|---|---|
| | Small Scale Feature | Pipe handrails | | Metal pipe handrails associated with concrete staircases. | 1959-1961 | Medium |
| | | | | | 1993 | Good |

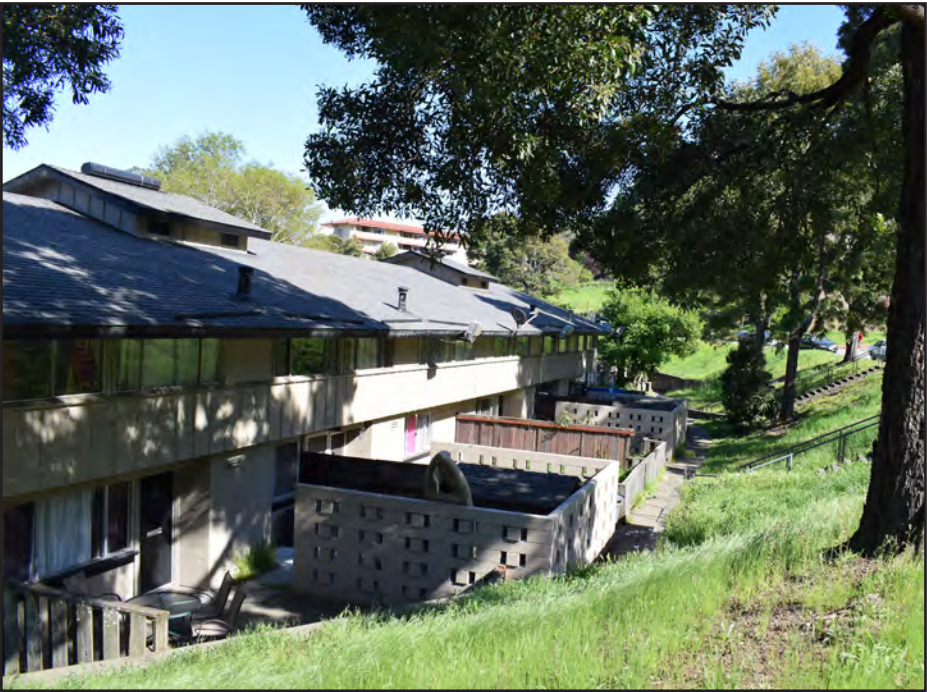
| Character Defining Features | Landscape Characteristic | Feature | Photo | Description | Date Built | Integrity |
|---|---|---|---|---|---|---|
| | Small Scale Feature | Fence and enclosure types in low-rise cluster | | Combination of fence and enclosure types surrounding low-rise buildings, consisting of screen fences, low fences, wood service fences, and concrete block walls. | 1959-1961 | Medium |
| | | | | | N/A | Fair |

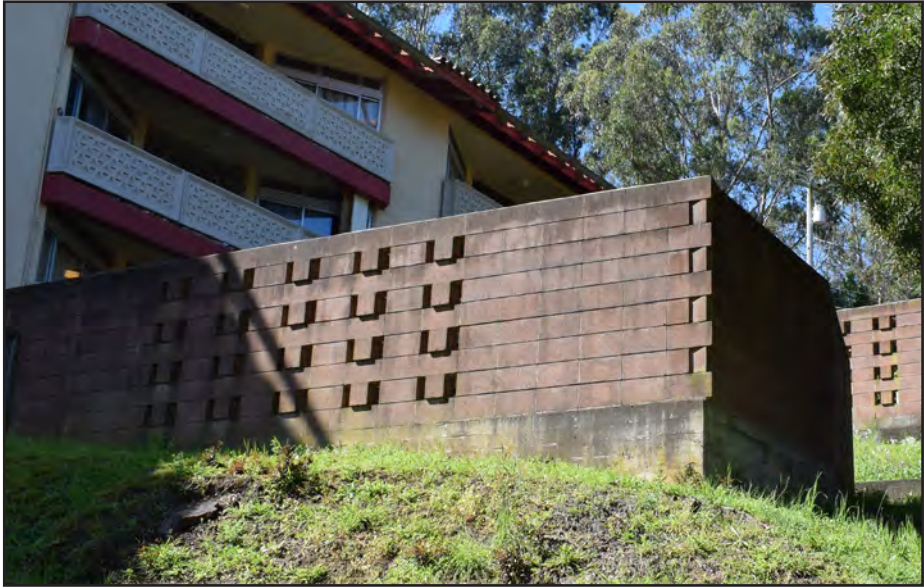
| Character Defining Features | Landscape Characteristic | Feature | Photo | Description | Date Built | Integrity |
|---|---|---|---|---|---|---|
| | Small Scale Feature | Masonry Screens | | Masonry screens in high-rise cluster surrounding laundry areas. | 1959-1961 | High |
| | | | | | N/A | Good |

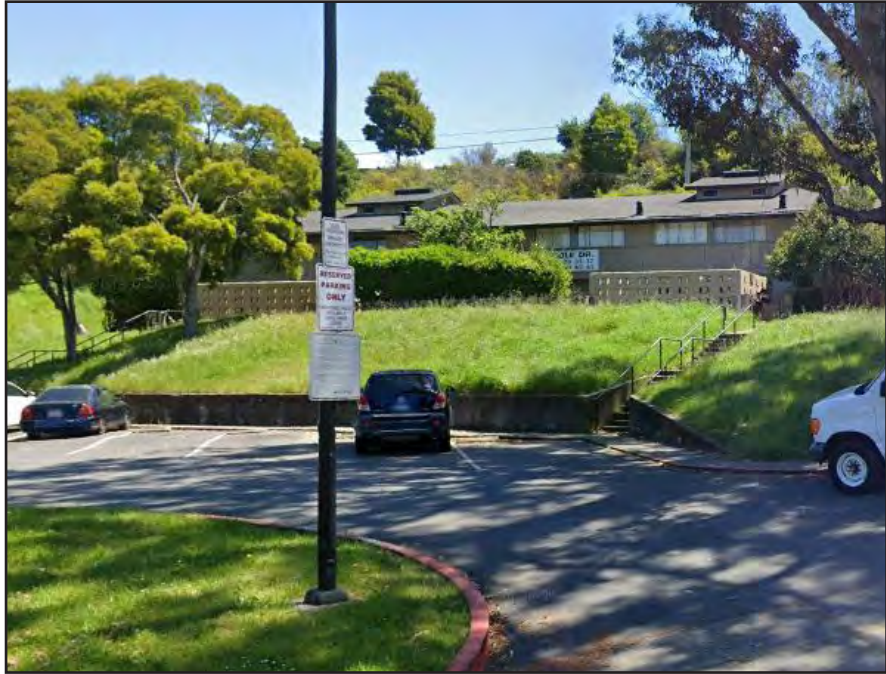
| Character Defining Features | Landscape Characteristic | Feature | Photo | Description | Date Built | Integrity |
|---|---|---|---|---|---|---|
| | Small Scale Feature | Concrete retaining walls | | Concrete retaining walls and seat walls. | 1959-1961 | High |
| | | | | | N/A | Good |

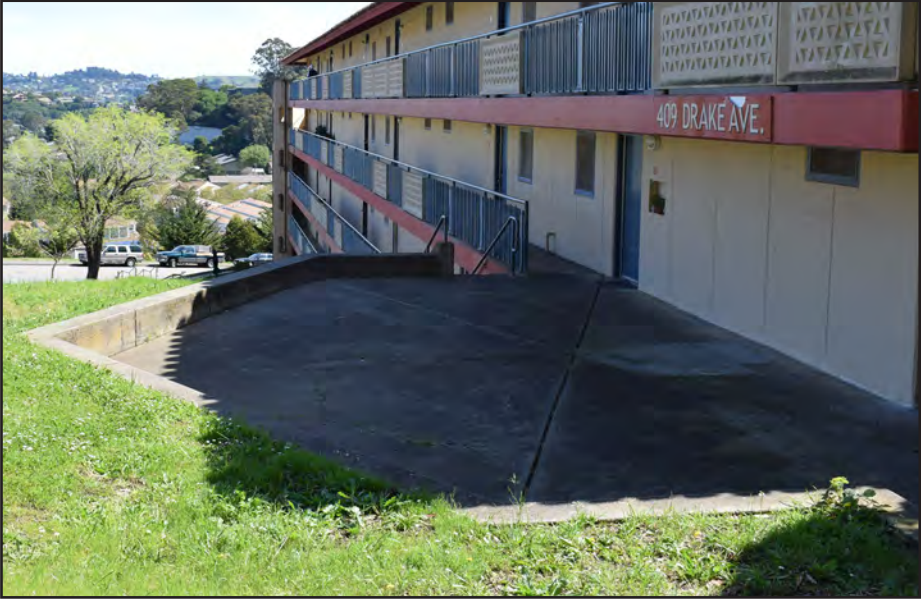
| Character Defining Features | Landscape Characteristic | Feature | Photo | Description | Date Built | Integrity |
|---|---|---|---|---|---|---|
| | Small Scale Feature | Pentagon terraces | | Pentagon-shaped terraces with seat walls. | 1959-1961 | High |
| | | | | | N/A | Good |

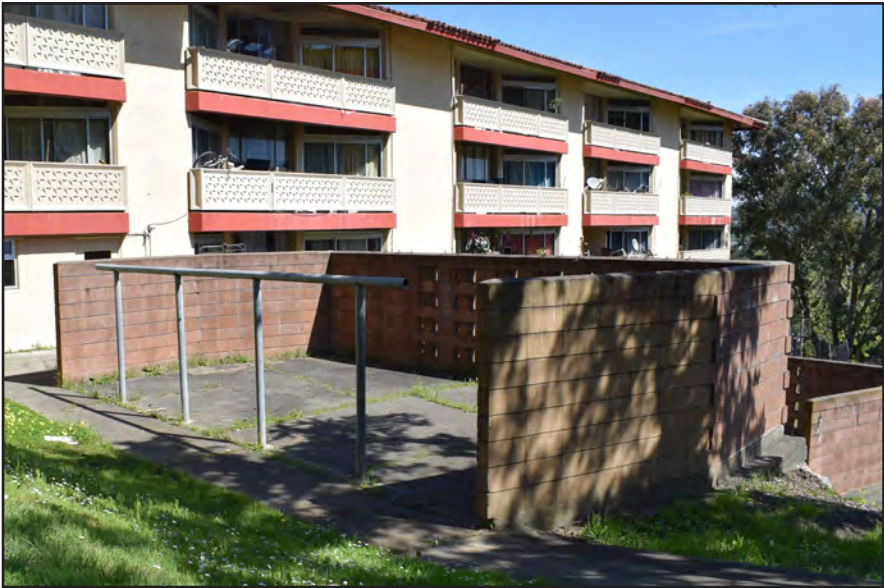
| Character Defining Features | Landscape Characteristic | Feature | Photo | Description | Date Built | Integrity |
|---|---|---|---|---|---|---|
| | Small Scale Features | Clothes lines | | Galvanized clothes lines set within the masonry screens in the high-rise cluster. | 1959-1961 | High |
| | | | | | N/A | Good |

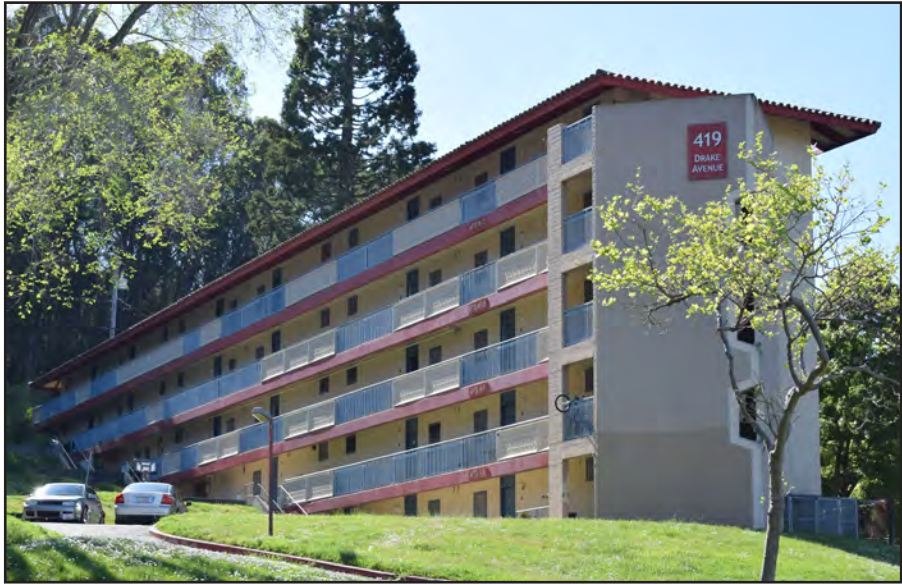
| Character Defining Features | Landscape Characteristic | Feature | Photo | Description | Date Built | Integrity |
|---|---|---|---|---|---|---|
| | Buildings and Structures | High-rise buildings | | Eight five-story rectangular plan buildings, containing multiple residential units and shared laundry/storage/utilities rooms. | 1959-1961 | Medium |
| | | | | | 2005, On-going | Good |

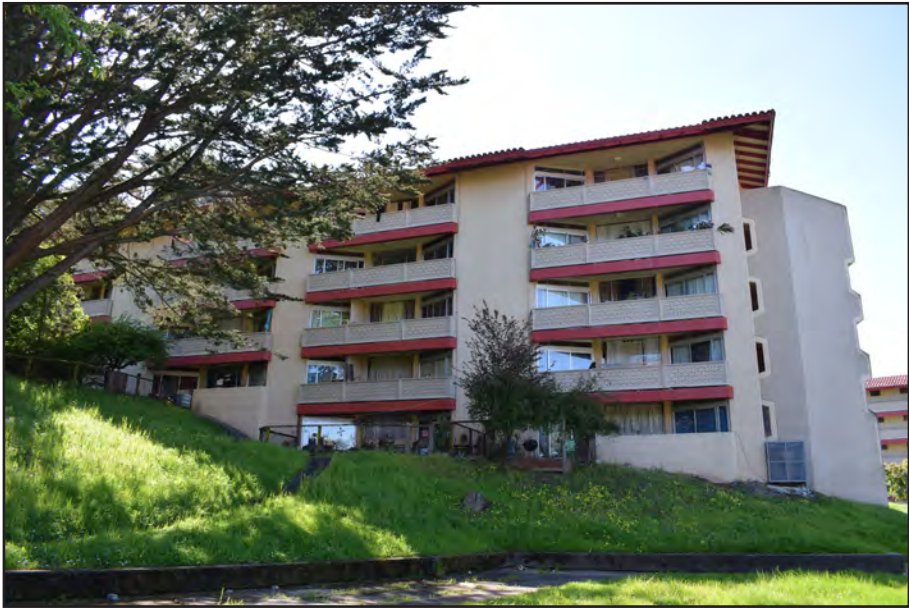
| Character Defining Features | Landscape Characteristic | Feature | Photo | Description | Date Built | Integrity |
|---|---|---|---|---|---|---|
| | Buildings and Structures | Concrete construction (High-rise buildings) | | The Type A High-rise buildings were built of concrete construction. | 1959-1961 | High |
| | | | | | N/A | Good |

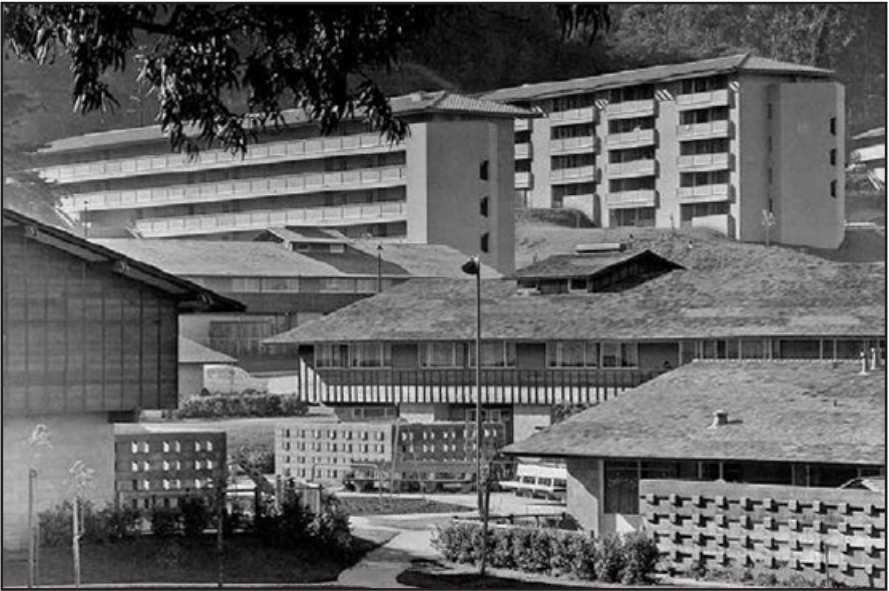
| Character Defining Features | Landscape Characteristic | Feature | Photo | Description | Date Built | Integrity |
|---|---|---|---|---|---|---|
| | Buildings and Structures | Hipped tile roofs (High-rise buildings) | | Hipped roofs clad in red clay tile. | 1959-1961 | High |
| | | | | | N/A | Good |

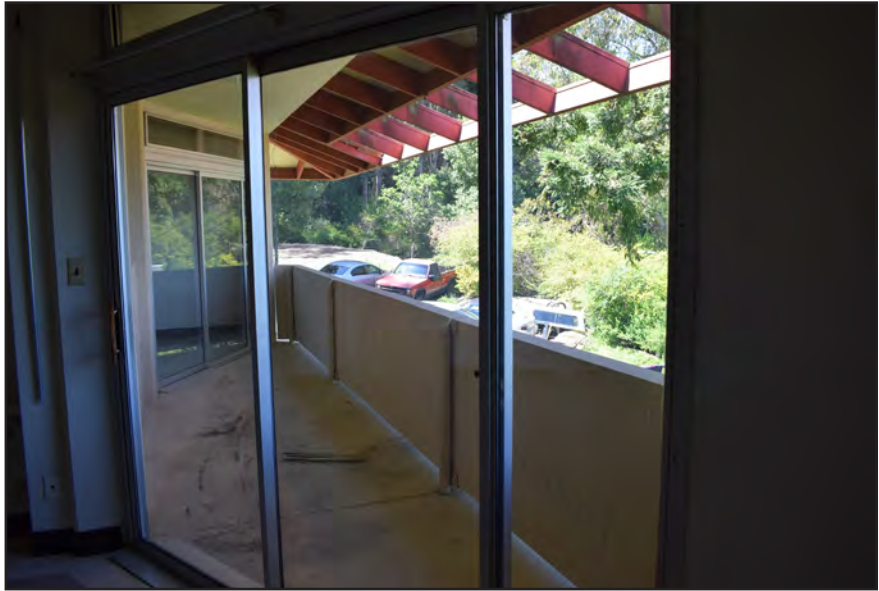
| Character Defining Features | Landscape Characteristic | Feature | Photo | Description | Date Built | Integrity |
|---|---|---|---|---|---|---|
| | Buildings and Structures | Adjoining private spaces (High-rise buildings) | | Adjoining private space at every unit, located at the rear facades of the high-rises. | 1959-1961 | High |
| | | | | | N/A | Good |

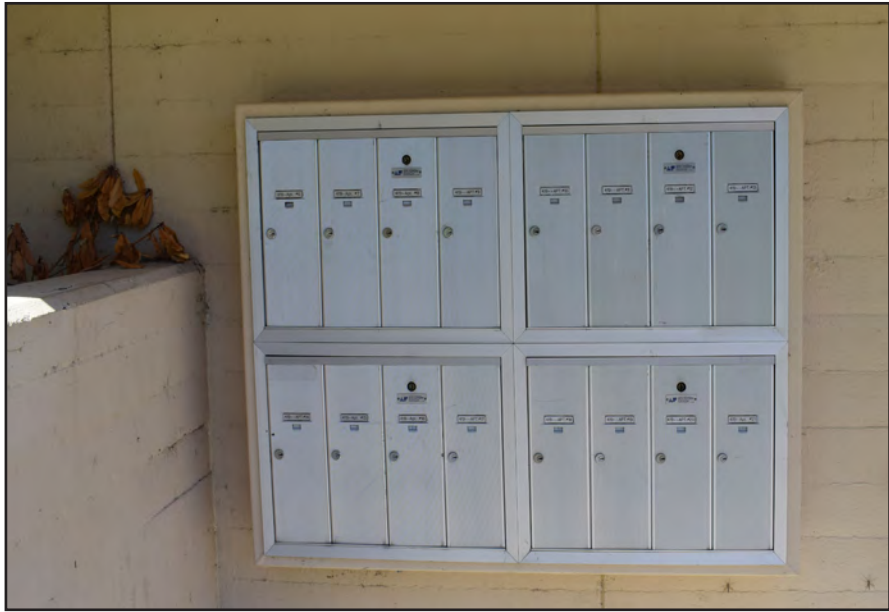
| Character Defining Features | Landscape Characteristic | Feature | Photo | Description | Date Built | Integrity |
|---|---|---|---|---|---|---|
| | Buildings and Structures | Metal mailboxes (High-rise buildings) | | Metal mailboxes affixed to the buildings' primary facades. | 1959-1961 | High |
| | | | | | N/A | Good |

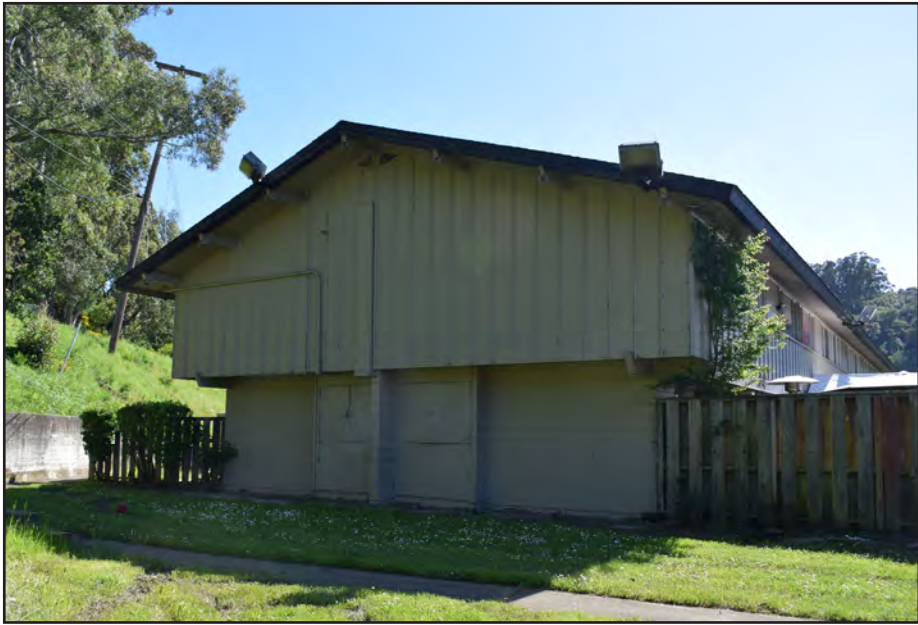
| Character Defining Features | Landscape Characteristic | Feature | Photo | Description | Date Built | Integrity |
|---|---|---|---|---|---|---|
| | Buildings and Structures | Rectangular plan (Low-rise buildings) | | 20 rectangular plan buildings, serving a multi-unit residential use. One building was converted to commercial use in 1985. | 1959-1961 | Medium |
| | | | | | 1985 | Good |

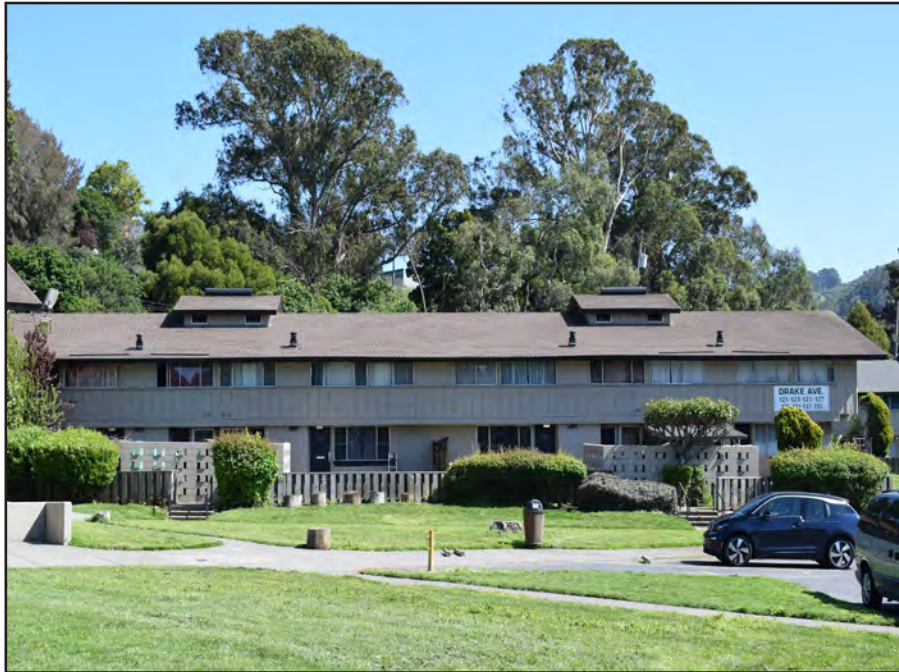
| Character Defining Features | Landscape Characteristic | Feature | Photo | Description | Date Built | Integrity |
|---|---|---|---|---|---|---|
| | Buildings and Structures | One-two story buildings (Low-rise buildings) | | The heights of the low-rise buildings vary depending on Type: Type B buildings are two stories in height; Type C and E buildings are one story in height. | 1959-1961 | High |
| | | | | | N/A | Good |

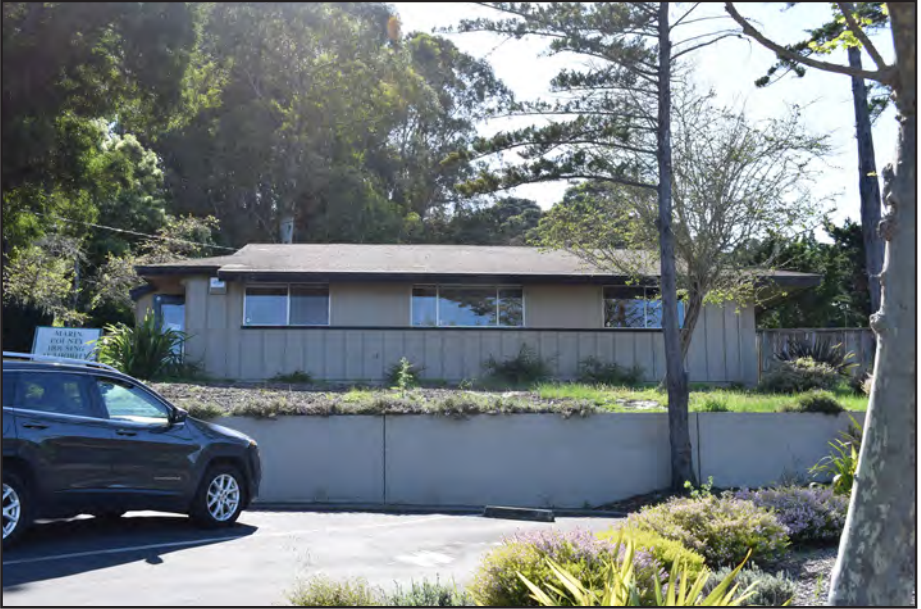
| Character Defining Features | Landscape Characteristic | Feature | Photo | Description | Date Built | Integrity |
|---|---|---|---|---|---|---|
| | Buildings and Structures | Single story height (Admin building) | | The Administration and Maintenance building is one story in height. | 1959-1961 | High |
| | | | | | N/A | Good |

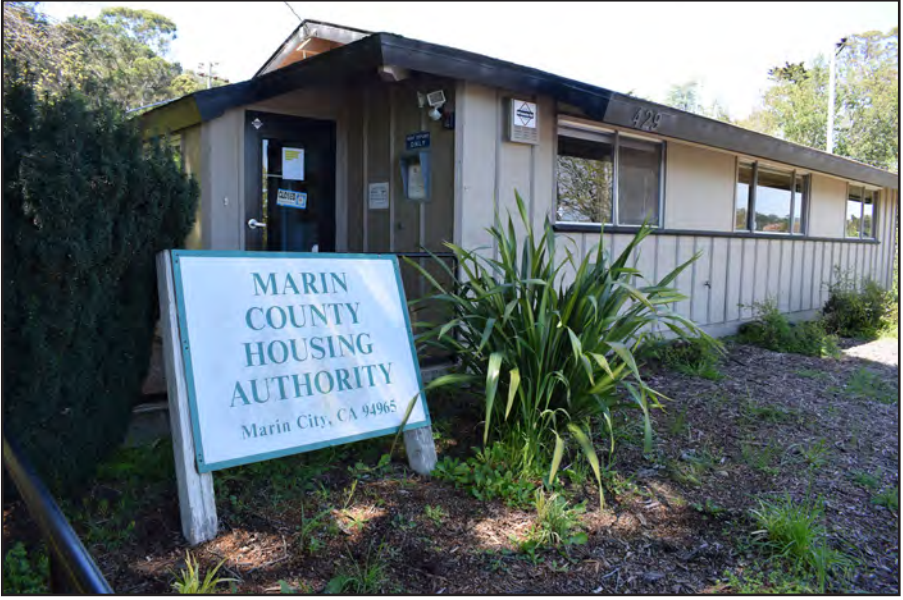
| Character Defining Features | Landscape Characteristic | Feature | Photo | Description | Date Built | Integrity |
|---|---|---|---|---|---|---|
| | Buildings and Structures | Construction techniques (Admin building) | | The concrete and wood frame construction techniques used at the admin building. | 1959-1961 | High |
| | | | | | N/A | Good |

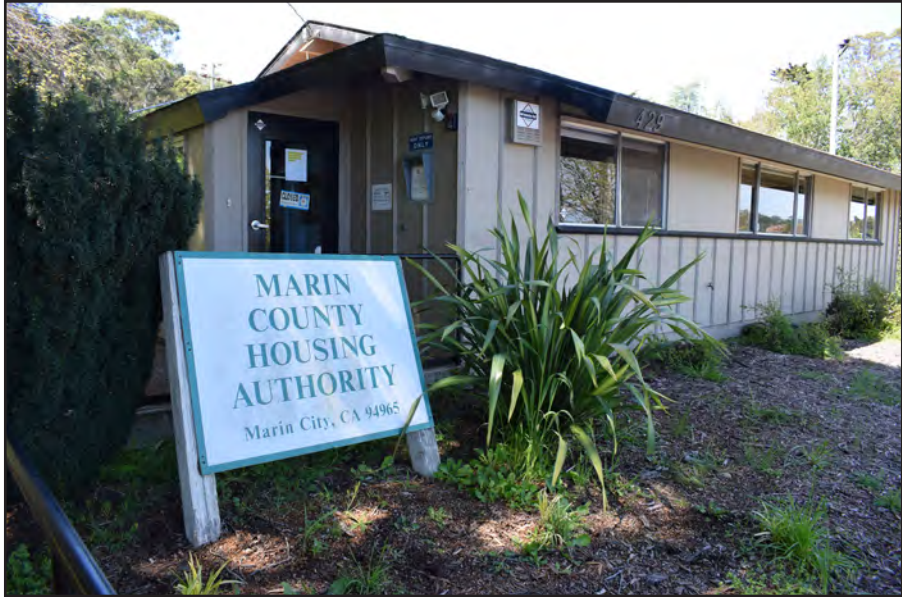
| Character Defining Features | Landscape Characteristic | Feature | Photo | Description | Date Built | Integrity |
|---|---|---|---|---|---|---|
| | Buildings and Structures | Redwood siding (Admin building) | | Redwood siding with vertical battens. | 1959-1961 | High |
| | | | | | N/A | Good |
